Seismic Retrofitting of RC Frames with RC Infilling (SERFIN Project)

JRC SCIENTIFIC AND POLICY REPORTS

SERIES Transnational Access report

TA Project Final Report

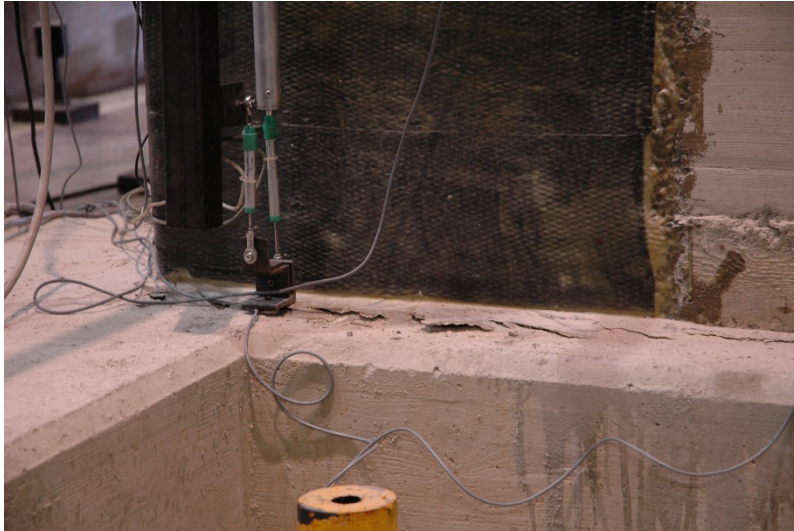
The first failure that could be observed visually was at the bottom of the wall in the south frame. The crack opened under the CFRP jacket at the ground floor as it can be seen in Figure 8.2 and Figure 8.4. In the northern frame such a failure was not observed, but more will be known when the results of the optical metrology become available.

Figure 8.2 Position 6: Crack opens at the bottom of the column - wall

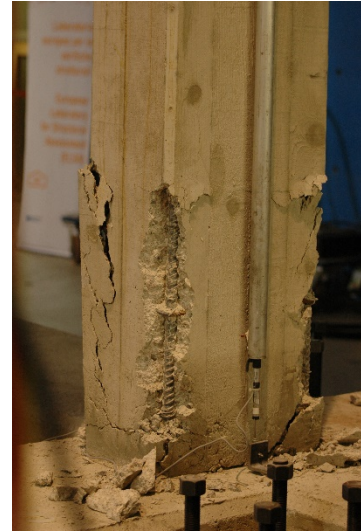
Following the failure in the south frame wall also the column in the column closest to the reaction wall suffered failure in the lap splice zone (Figure 8.3). Throughout the test this column suffered the most severe damage but continued to carry compression load, whereas it was visible that the joint failed in tension. The column on the opposite side (position 5) did not suffer damage, apart from some cracks in the lap splice zone.

Figure 8.3 Position 8: Failure of the column at the bottom

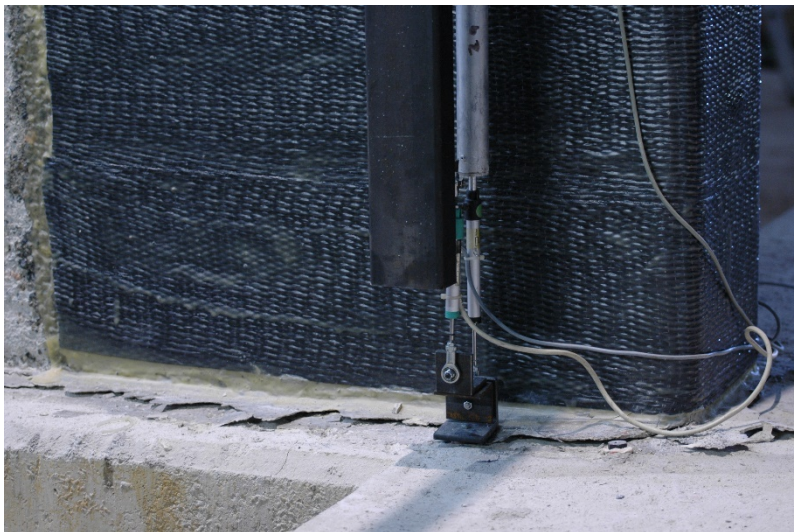
Figure 8.4 Position 7: Crack opens at the bottom of the column - wall

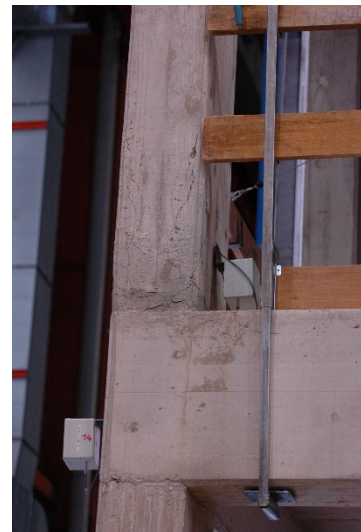
Cracks developed in west columns of both the north and south frames at the first and second storey (Figure 8.5 and Figure 8.7). The cracks, their position and concrete spalling in the latter phase suggest lap splice failure in tension. West columns in the ground floor remained without visual damage.

Figure 8.5 Position 12: Failure of the laps splice joint, N frame

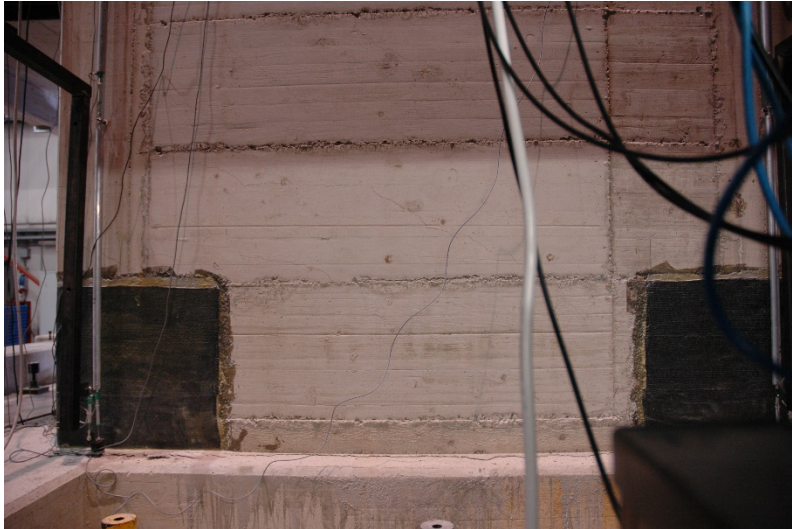
Hairline cracks developed also in the ground floor of the south wall (Figure 8.6) but no major damage was observed in the wall or the connection with the surrounding frame. However a horizontal crack did appear in the foundation beam.

Figure 8.6 Position 1S: Hairline cracks develop in the wall

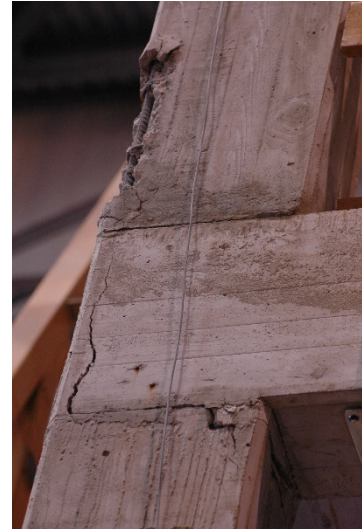
Figure 8.7 Position 29: Failure of the lap splice joint, S frame

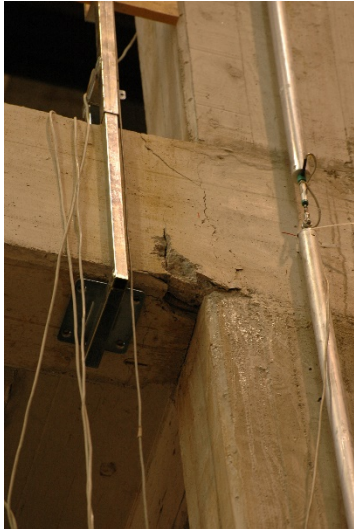
All beams next to the walls at all storeys were damaged in the cyclic test, typically as seen in Figure 8.8. The damage indicates yielding of the longitudinal reinforcement. In spite of the joints not having been designed for ductility, they retained most of their bending capacity, as the level of damage was minor.

Figure 8.8 Position 30: Beam next to the wall is cracked

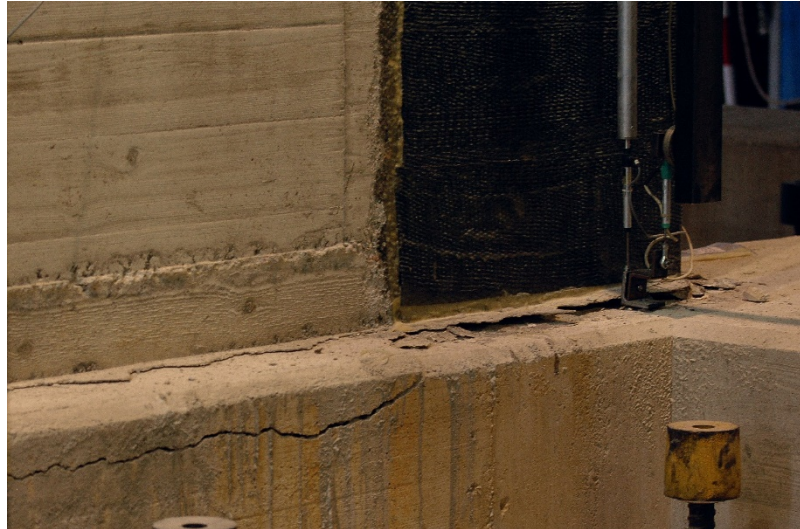
In the last test the horizontal crack opened further at the bottom of the north and south wall (Figure 8.9, Figure 8.10 and Figure 8.12). The crack ran under the CFRP jacket which kept other parts of the columns undamaged. Cracks also developed in the foundation beams (Figure 8.9) under the walls, which compromised local displacement measurements of the transducers fixed at the foundation

Figure 8.9 Position 7: Horizontal crack developed also in the foundation beam

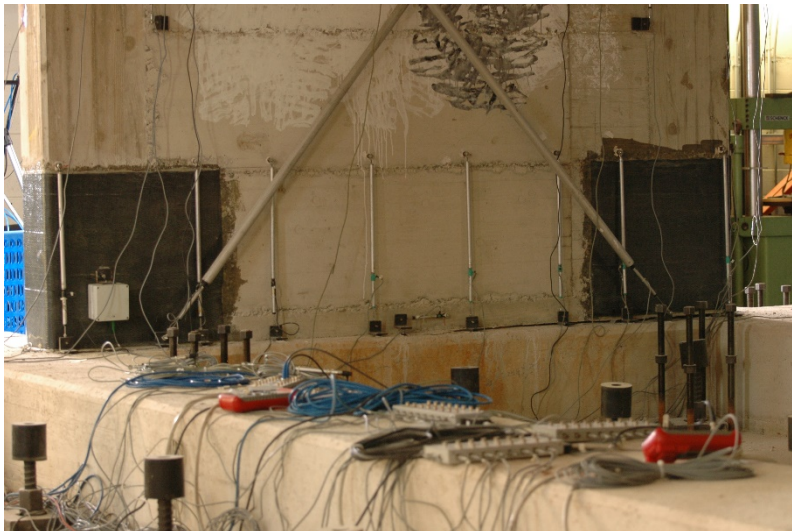
Figure 8.10 Position 1N: A crack opened also in the northern wall at the bottom

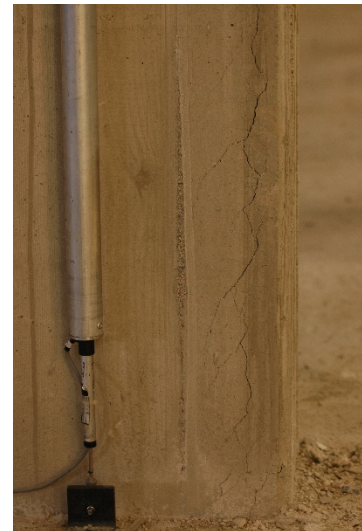
Both ground floor columns closest to the reaction wall (Figure 8.11 and Figure 8.15) were damaged in the lap splice zone, both columns failing in tension but with some remaining vertical load carrying capacity. As in the 0.25g test, damage to the southern frame was much more significant.

Figure 8.11 Position 1: Damage to the north wall column

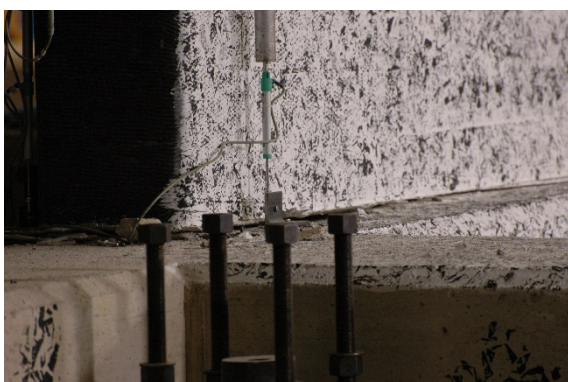
Figure 8.12 Position 2: Crack opened under the CFRP jacket

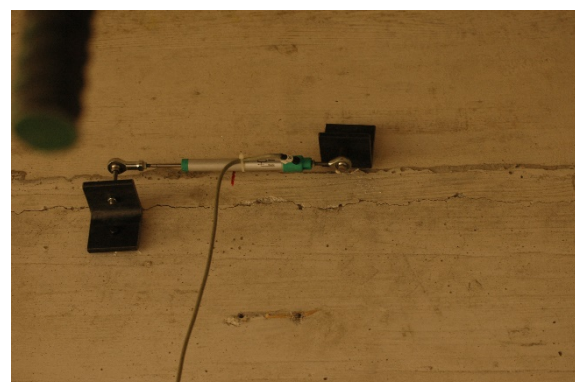
In the ground floor cracks between the infill wall and the surrounding frame were noticed (Figure 8.13), indicating slip between these two elements. However, local measurements show that the horizontal slip (between wall and beam) remained under 0.8mm (Figure 10.56), whereas the vertical slip (between wall and column) remained under 0.4mm (Figure 10.57).

Figure 8.13 Position 1S: Slip crack at the top of the southern wall in the ground floor

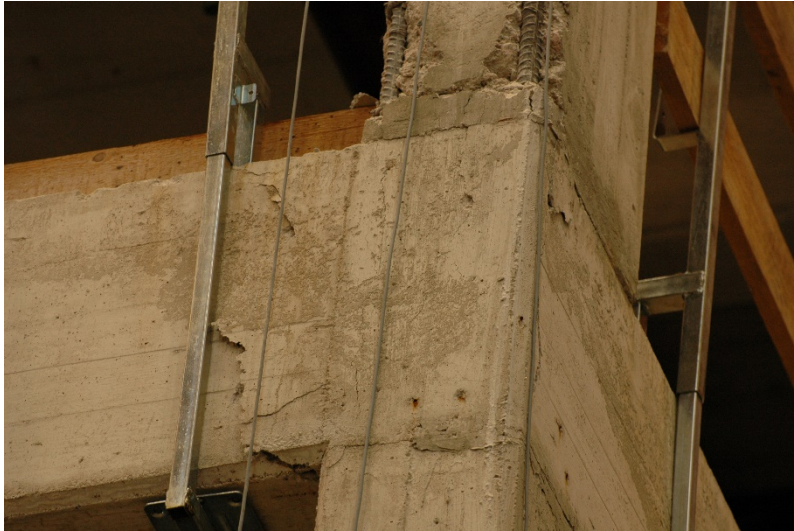
The remaining beam-column joints suffered moderate damage, which was most pronounced in the western part of the two frames. The cracks developed at the bottom of columns and propagated into the beams (Figure 8.14).

Figure 8.14 Position 29: Cracks propagated into the cross beam

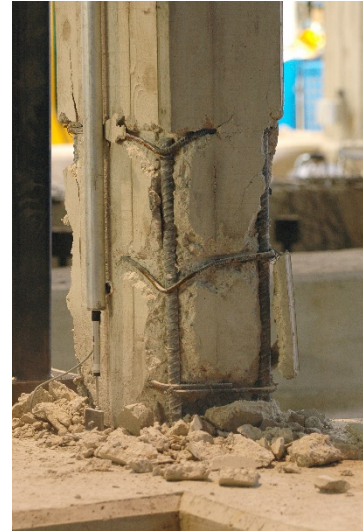
Figure 8.15 Position 8: Column is severely damaged
