# Monitoring Cultural Heritage Sites Affected by Geohazards in Cyprus Using Earth Observation

**Kyriacos Themistocleous**

**Abstract** Monitoring geo-hazards of cultural heritage sites and structures as well as the surrounding archeo- landscapes facilitates the early recognition of potential risks and enables effective conservation, monitoring and planning. Landslides, earthquakes and erosion are the predominant geo-hazards in Cyprus. In order to identify and monitor geohazards and environmental displacements, Earth Observation techniques can be used in combination with long-term low-impact monitoring systems, such as UAVs and geodetic techniques to monitor and assess the risk from geohazards on cultural heritage sites and structures to evaluate potential changes and risks.

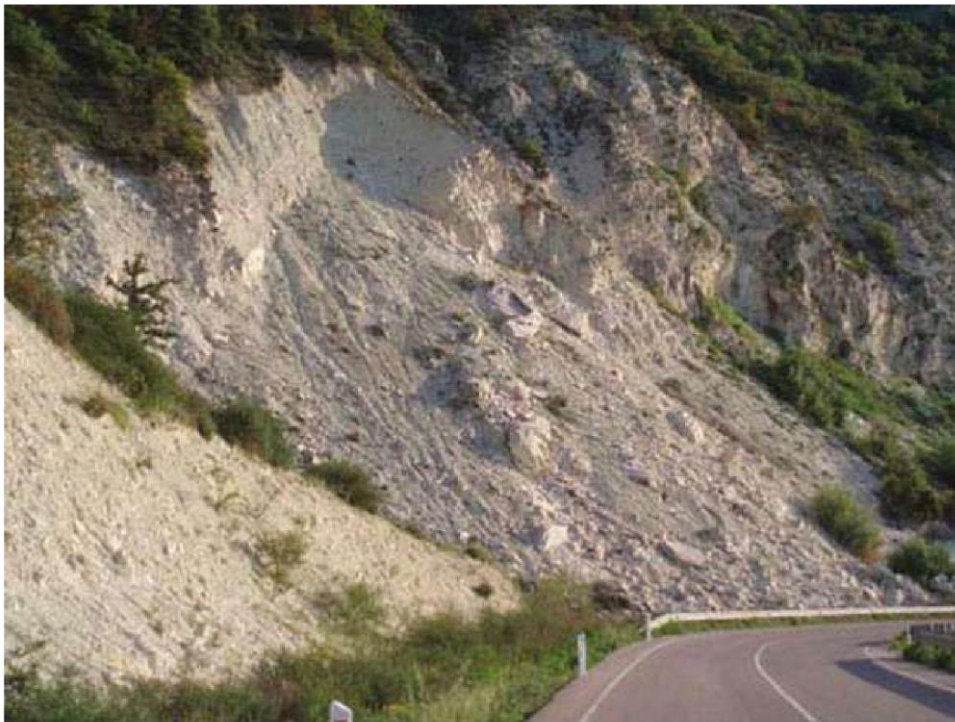
**Fig. 1** Landslide, Paphos-Limassol Highway in Cyprus

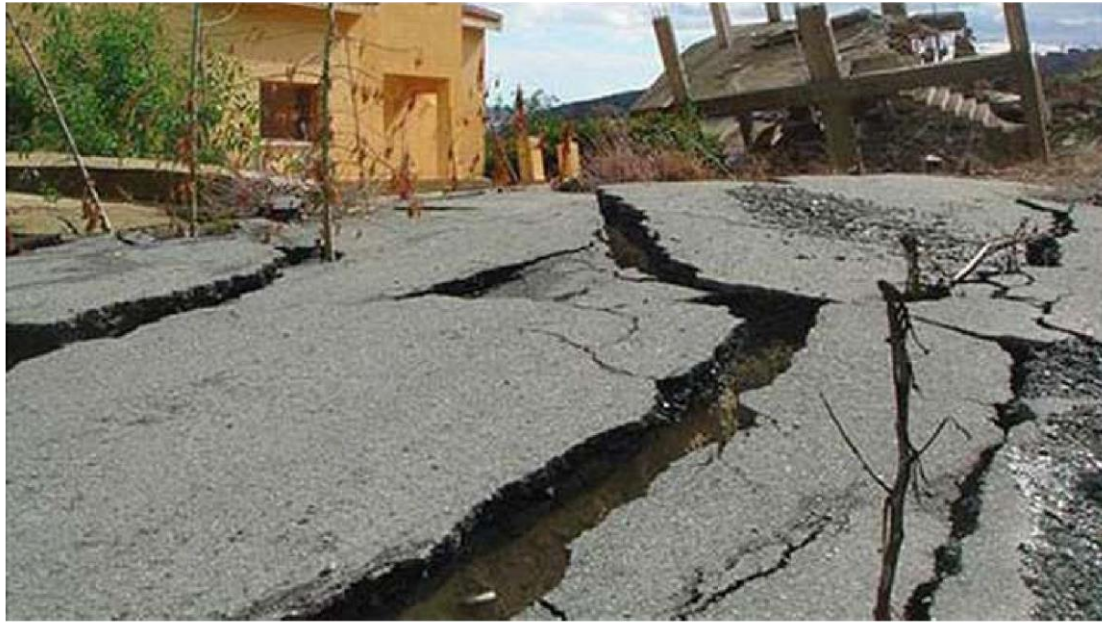
**Fig. 3** Landslide in Pissouri area in Cyprus

Landslides have resulted in significant damage to the Pissouri area in the south-west area in Cyprus (Fig. 3). The south western side of Cyprus has a long history of slope instability problems due to its morphological and hydrological conditions. Various factors have contributed to the current pattern of slope instability, such as climate change with intensive rainfall, hydrological conditions, land cover and land use changes (Tzouvaras et al. 2020). In this area, the remains of former sea-floor deposits and massive submarine slides, are exposed in the Paphos District situated between the Troodos Mountains and the sea. These deposits tend to be heavily deformed and are rich in the types of clay minerals that are prone to landslides (Tzouvaras et al. 2020). This tendency is exacerbated by the steep terrain and the long history of powerful earthquakes in the region (British Geological Survey). The terrain is characterised by steep-sided plateaux made up of ‘Melange’ and ‘Kannaviou Clay’ capped by thick chalk sequences.

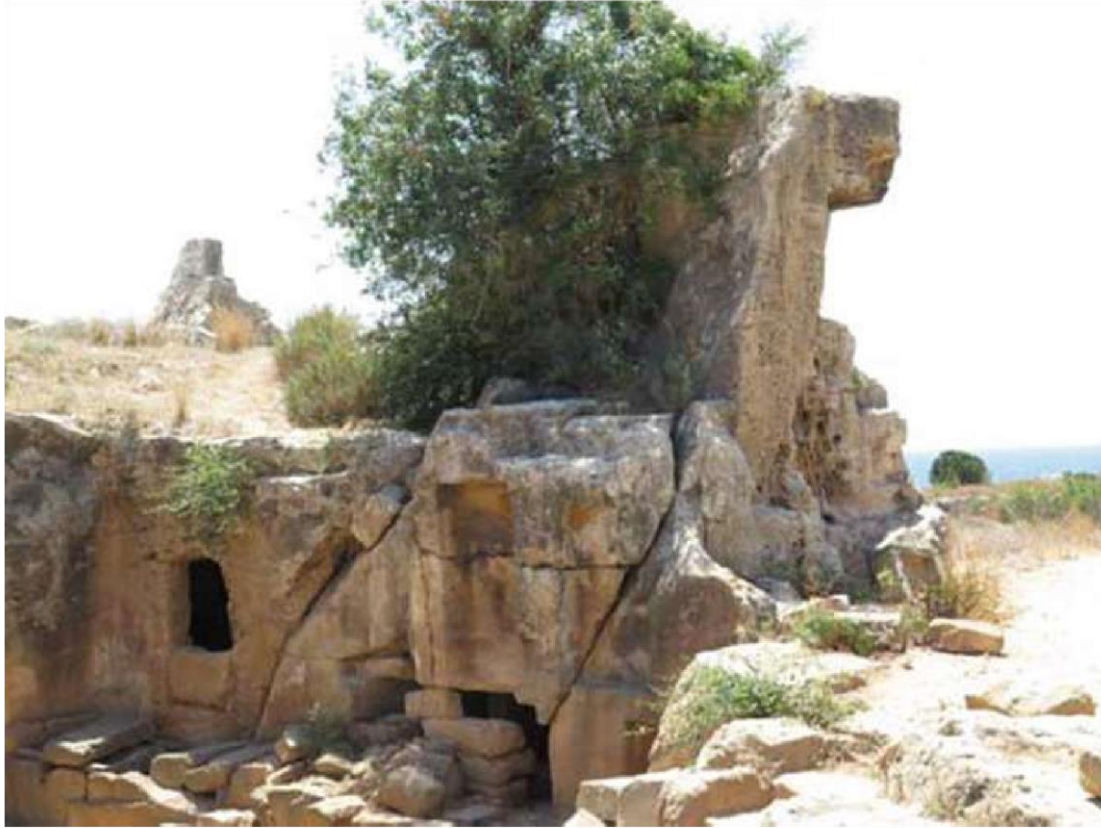
**Fig. 5** Erosion in the Tomb of the Kings region, Paphos (*Source* A photograph taken by Kyriacos Themistocleous in 2017)

2018). Changes in atmospheric acidity, landform development, and vegetation cover rapidly affect the intensity and rate of the erosion process (Fig. 5).

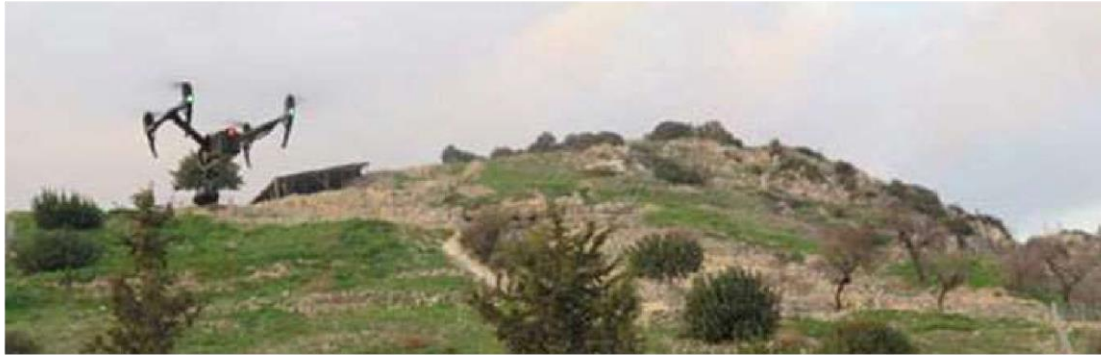
**Fig. 10** UAV flight over Choirokoitia area

Images generated from UAVs are used to document cultural heritage sites under threat from geo-hazards (Fig. 10). Hundred of UAV images are used to create ortho-photos, dense point clouds, 3D model and Digital Elevation Models (Themistocleous 2017). It is recommended that UAVs be equipped with a high-resolution camera to acquire images over a site with fixed ground control points for geo-referencing in order to produce a photogrammetric ortho-image and point.
