Article

Integrated Investigation of Built Heritage Monuments: The Case Study of Paphos Harbour Castle, Cyprus

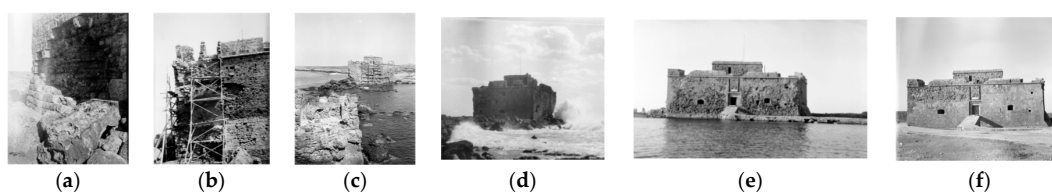
Figure 2. (from left to right): (a) Extended destruction of the external masonry wall (Archive of the Department of Antiquities of Cyprus, 1936); (b) Restoration works on the external north wall (Archive of the Department of Antiquities of Cyprus, 1939); (c) Conservation works on the south wall masonry (Archive of the Department of Antiquities of Cyprus, 1938); (d) The absence of water break infrastructure led to monument exposure, especially its western side (Archive of the Department of Antiquities of Cyprus, 1939); (e) East façade (Archive of the Department of Antiquities of Cyprus, 1939); (f) East façade (Archive of the Department of Antiquities of Cyprus, 1964).

The restoration and conservation of the monument by local authorities started when the Department of Antiquities of Cyprus was established in 1935 (Figure 2a–f). The various actions that took place towards its preservation are briefly described in the Annual Reports of the Department of Antiquities of Cyprus (ARDA). Some of the major restoration and/or conservation works accomplished are briefly described here:

During 1938–1939, the reinforcement of sections of the ancient breakwater on which the castle rests was carried out. These sections had to be further reinforced with concrete in 1949 after being eroded again by the sea (ARDA 1949).

The earthquake of 1953 provoked great cracks along the walls of the castle. The cracks in contact with rain water were initially filled as a temporary remedy (ARDA 1953). Later on, other actions were taken, such as the placement of a hidden reinforced concrete collar around the outer walls of the entrance lintel level (ARDA 1955). By 1956, all the damages provoked by the earthquake had been repaired (ARDA 1956), while injections for feeling cracks as well as the replacement of severely weathered building blocks were reported in the following years (ARDA 1960, ARDA 1961, ARDA 1966, ARDA 1967). Between 1968 and 1969, a breakwater was built in the southwest part of the castle to protect its intensively weathered foundations [21,22].

The castle went through intensive repairs after the 1974 bombarding (Karageorghis, 1974–1976). The replacement of corroded stones in the inside and outside of the castle, as well as the grouting and filling of cracks, was reported within the following years (Karageorghis, 1977–1984 (1975–1985); Karageorghis, 1986–1987 (1987–1988); Loulloupis, 1991 (1992); Christou, 1992 (1998); Christou 1993–1994; Hadjisavvas 1995–1996; Hadjisavvas 1998; Flourentzos 1999) [22–24].

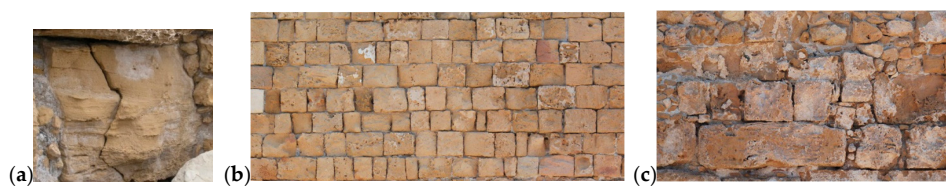
Cracks and deformation were not found on the monuments' external walls, apart from local fracturing developed in the cross-section of specific building stones, which was an isolated case for the monument and is probably due to local overloading (Figure 4a).

The detachment group presents few cases of fragmentation patterns and decays of the delamination/exfoliation pattern due to salt crystallization. Many stone blocks present perimetrical exfoliation, which leads to the pulverization of part of the construction blocks and the detachment of stone fragments. Also, loose material from the joint mortars was extended in most of the south wall (Figure 4b). Discolouration induced by efflorescence patterns and salt crusts was observed to be more intense on the southern wall (Figure 4c).

Biological colonization was limited and consisted mainly of the plants observed growing on the external south wall of the monument (Figure 4d). The roots of some plants can cause significant stress problems to the stones on and around which they develop, as they form places with high humidity.

Figure 4. Individual fissures, clearly visible to the naked eye (a); Loss of mortar joints between the masonry blocks (b); Surface discoloration in the form of salt efflorescence pattern (c).

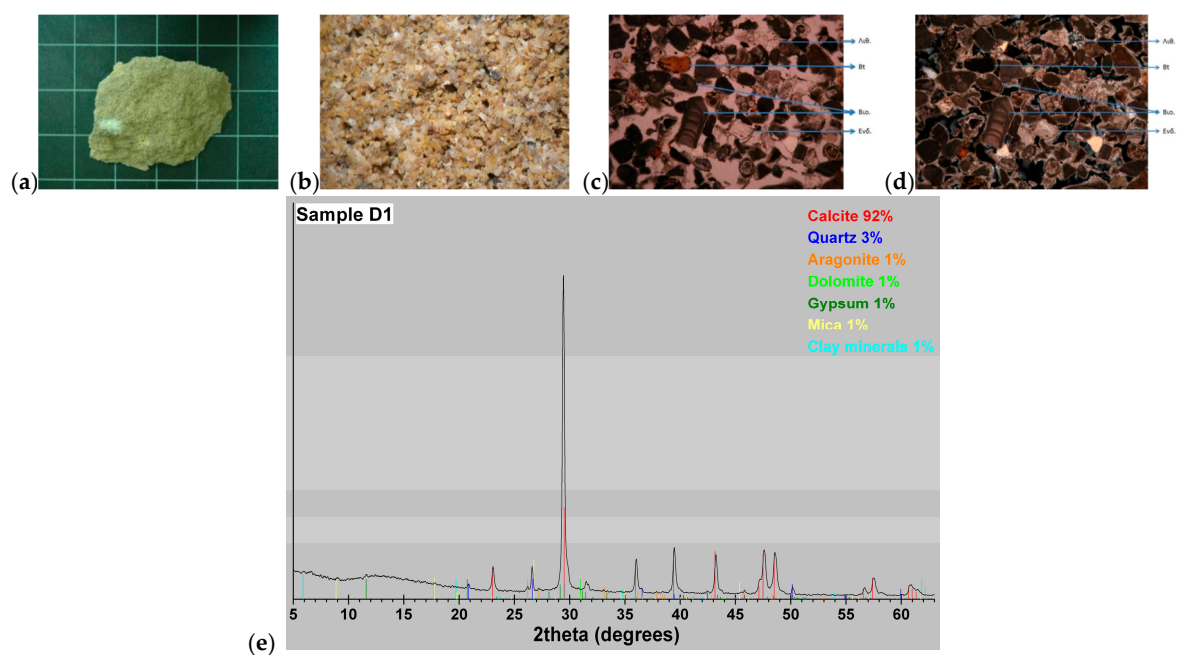
The laboratory analysis resulted in a series of information for each sample (Figure 5). Stereoscopic observation permitted the colour and composition characterisation (Figure 5b), while the results of the microscopic examination as shown in Figure 5c,d for sample No. 1 revealed a variety of information related to the texture of the rock, the mineralogical composition, the high porosity, the presence of cement material, their petrographic classification, and other information. Also, in Figure 5e, a representative XRD pattern is provided.

Figure 5. Results from sample no. 1 (from left to right) (a) Macroscopic observation (b) Stereoscopic observation (max. image enlargement 11 mm) (c) Microscopic observation (N//, max enlargement 3 mm) (d) Microscopic observation (N[^], max enlargement 3 mm) (e) X-ray diffractometry of sample D1.

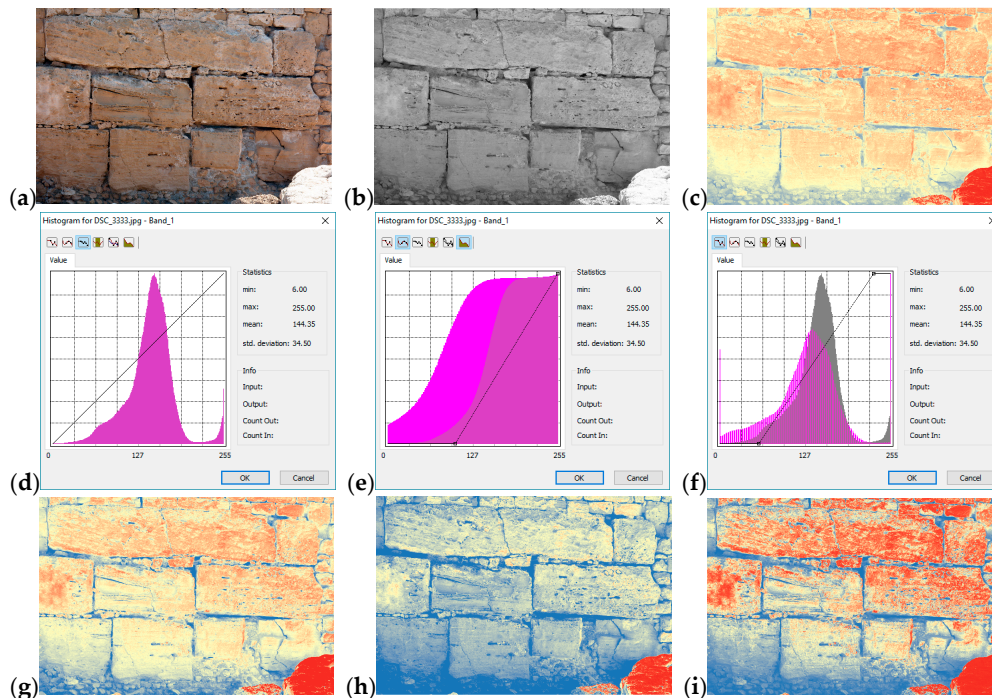
Digital image processing was applied to the rectified images of the monument's external surfaces. Through this process, the earlier identification of the various stone deterioration patterns was visualized, initially by image segmentation. Thresholding is the simplest method of image segmentation since the algorithm divides an image into two (or more) classes of pixels. For the example under examination here, natural breaks of the rectified image's histogram were used in all three bands (i.e., blue–green–red bands). As shown in Figure 7, the individual spectral bands of the

RGB image (Figure 7a) can be visualized either in grayscale or in a colourmap range (Figure 7b,c, respectively). Then histogram enhancement techniques such as minimum–maximum and standard deviation were applied (Figure 7d–f) to improve the interpretation of the image (Figure 7g–i).

Figure 7. (a) RGB initial rectified image; (b) greyscale colourmap of the blue band (Band 1); (c) colourmap of blue band; (d) initial histogram of the blue band with no histogram enhancement; (e) min–max threshold (min: 100 and max: 250) histogram enhancement applied for the blue band; standard deviation histogram enhancement applied for the blue band; (g–i) colourmap of the blue band after the application of (d–f) respectively.

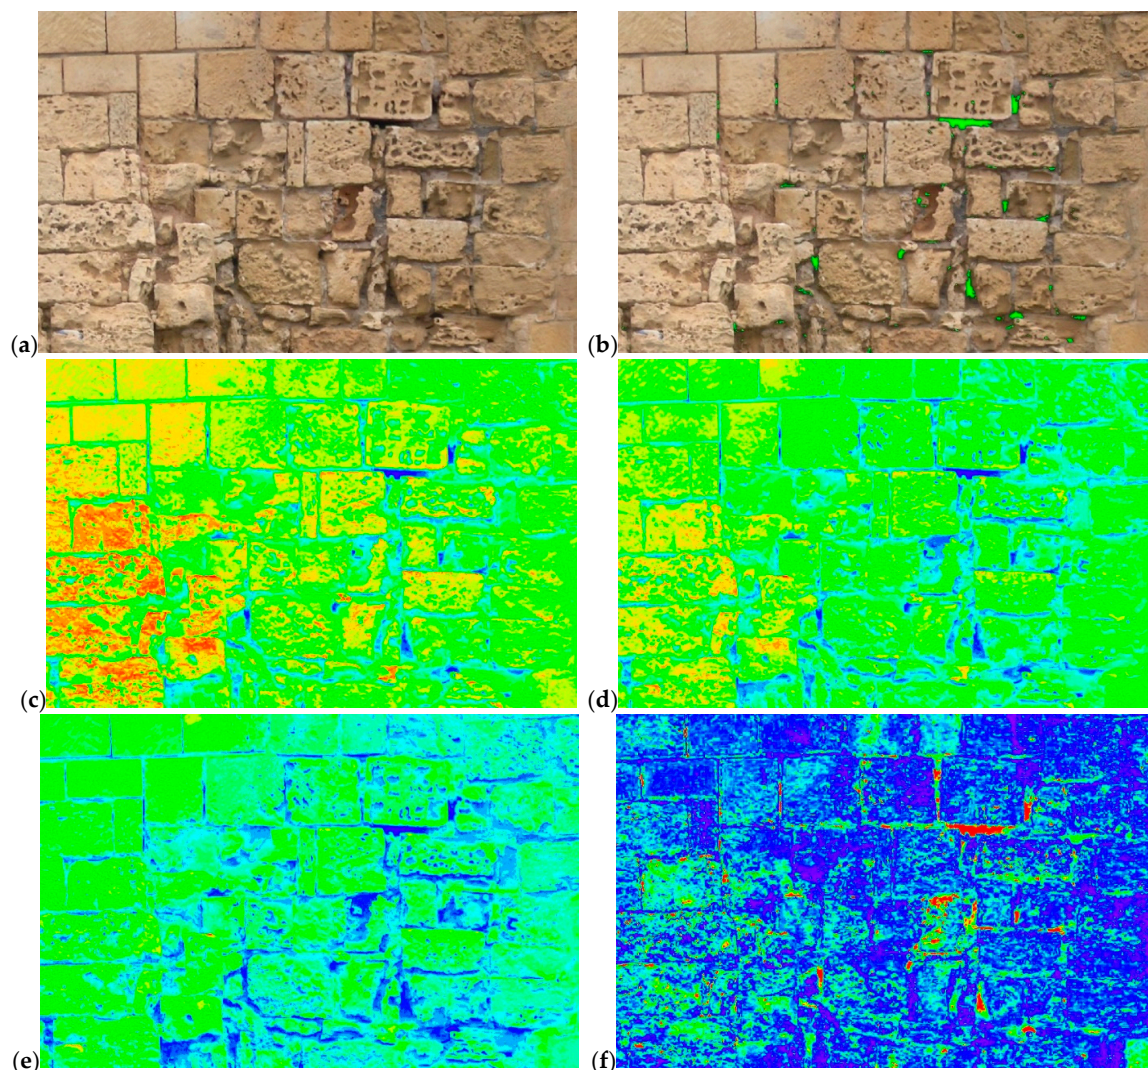
Figure 8 shows the results after adding specific threshold values, which were defined based on the visual inspection (Figure 8c–e). Indications with the same colour define the same optical properties (of the specific wavelength) for the external material of the façade. This can allow a fast and first documentation of the external façade of the monument, taking into consideration that other parameters such as showdown can also affect the outcome. The specific range of the threshold can also be isolated and visualized, as shown in Figure 8b, thus identifying the mortar loss from the joints.

Further image analysis was also applied using the RXD anomaly detection algorithm. This method enabled the mapping of the various alterations in the whole external surface, creating the possibility to quantify the extension of each one in terms of percentage and thus in terms of square meters. The results after the application of the RXD algorithm are shown in Figure 8f. Areas highlighted in blue are regions that are considered smooth, referring to the healthy masonry blocks. In contrast, areas that are highlighted in red are areas that highly possibly suffer from stone decay.

In addition to thresholding and the RXD algorithm, a supervised classification (SVM) was applied using specific areas of the image as training samples. Image classifiers offered the possibility to detect and visualize various types of anomalies on the built wall surface and to understand the alteration level.

Figure 8. State of preservation of the main (north) façade of the castle using DIP techniques: (a) image; (b) adding threshold values in the image; (c) colour scale to the blue band; (d) colour scale to the green band; (e) colour scale to the blue band; and (f) RXD anomaly detection.
