Seismic and energy upgrading of existing buildings—full-scale testing of retrofitted masonry-infilled RC frames

cyclic in-plane loading, energy and seismic retrofitting, full-scale testing, masonry-infilled RC frame, phase change material (PCM), textile reinforced mortar (TRM)

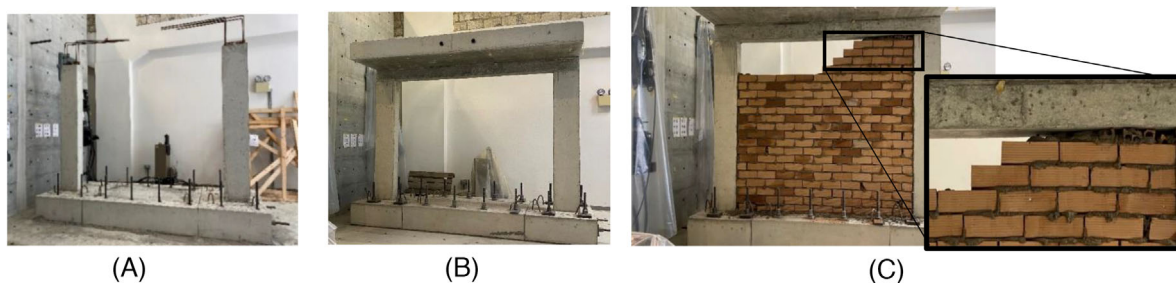
The construction of each RC frame was implemented in two stages. First, each RC column with its foundation pad were precast along with an RC foundation beam and were positioned in the laboratory (Figure 3A). Then, the T-beam above the columns was cast inside the laboratory (Figure 3B). The columns' foundation pads and the foundation beam were fixed on the laboratory's strong floor with vertical prestressed anchors and were connected together through horizontal prestressing rods. The RC foundation beam (with dimensions equal to $2000 \times 1300 \times 400 \text{ mm}$) remained fixed for all the masonry-infilled RC frame specimens. Details regarding prestressing are provided in the next section.

FIGURE 3 Construction of masonry-infilled RC frame (A) placement of precast RC columns and foundation RC beam, (B) construction of RC T-section beam, and (C) building of masonry infill wall with detail of the last row of bricks.

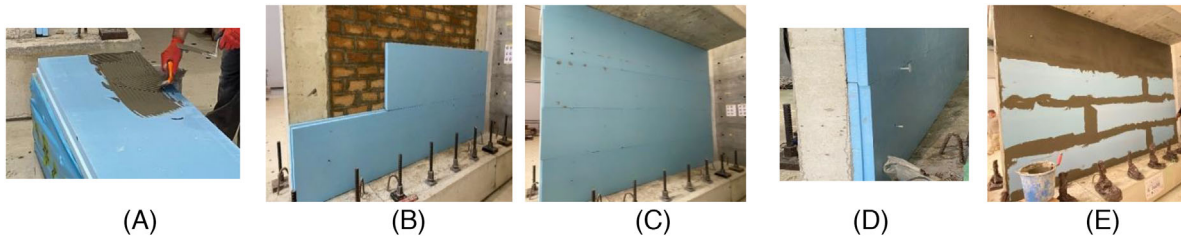
FIGURE 6 XPS boards application steps (A) adhesive material at the surface of the XPS using notched trowel, (B) application of the first and second strips of XPS board, (C) infilled frame with four and half XPS boards, (D) application of special plastic dowels, and (E) adhesive material at the surface of the XPS using notched trowel.

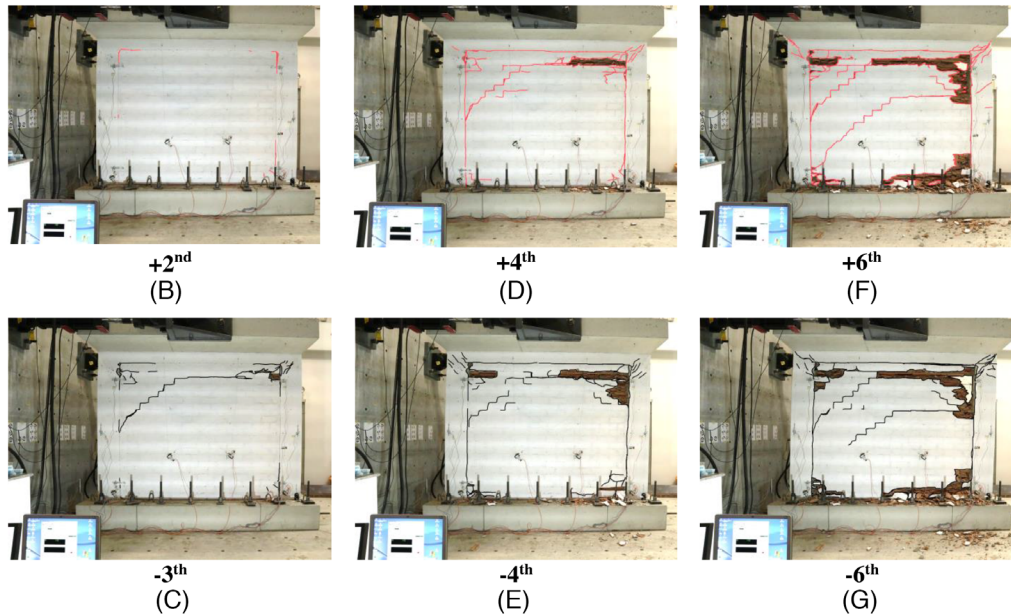
The control specimen was subjected to six cycles of displacement-controlled loading which resulted to a maximum imposed displacement of ± 55 mm ($\pm 1.96\%$ drift ratio). Figure 9 presents the base-shear force in relation to the top-displacement (hysteresis curve) and the progression of cracking at the front side of the specimen for the second, fourth and sixth cycles of loading. The maximum base-shear force was attained during the second cycle of loading at corresponding top-displacement of +9.9 mm (drift ratio of +0.35%), in the positive direction and is equal to +335 kN. In the negative direction the maximum base-shear force was recorded during the third cycle of loading corresponding to a top-displacement of -15 mm (drift ratio of -0.53%) and is equal to -309 kN. The peak base-shear and the peak drift ratio in each cycle of loading for all the specimens are presented in Table 3 for the benefit of the reader. During the second cycle of loading minor cracks formed at the lower right corner of the infill wall and sliding cracks developed along the infill-column and infill-beam interfaces as shown in Figure 9B. During the third cycle of loading, one step-type crack developed at the left of the infill wall as shown in Figure 9C, and it propagated to the right corner of the infill wall, while minor sliding cracks were also formed at the upper left and lower right corner of the infill wall. In addition, shear cracks developed at the upper ends of the columns, which were more visible at the upper end of the right column, and they propagated in the beam-column joint. During the fourth cycle of loading, the base-shear was equal to ± 230 kN at a corresponding drift ratio of $\pm 0.89\%$, as shown in Figure 9A, which represents a 23%–33% reduction in lateral resistance compared to that of the previous cycle. During this cycle of loading (Figures 9D,E), the previously formed step-type crack along the diagonal of the infill wall and the cracks at the upper corners of the infill wall reopened and became wider leading to the *corner crushing of the infill wall*. Furthermore, the shear cracks at the upper ends of the columns also reopened and became wider indicating the shear failure of the upper ends of the columns. Shear failure of the columns was possibly the result of a *short column mechanism* which occurred due to the partial restraint imposed by the infill wall after the failure of its upper corner part. As the displacement loading increased, a marked decrease in the lateral resistance and stiffness of the infilled frame was observed. During the last cycle of loading the base-shear was equal to 221 kN and -157 kN at corresponding displacements of 54.9 mm and -55 mm, respectively (drift ratio of $\pm 1.96\%$). In this cycle, the cracking pattern was formed completely as shown in Figures 9F,G with the formation of two step-type cracks (width of the crack ranges from 5 to 10 mm) indicating

FIGURE 9 Response of M-specimen (control specimen). (A) Base-shear versus top-floor displacement, (B) the crack patterns during the second cycle of loading, (C) third cycle of loading (negative direction), (D) during the fourth cycle of loading in the positive, and (E) negative direction, and during the sixth cycle of loading (F) positive and (G) negative direction.

the *diagonal cracking* combined with *sliding shear failure* of the wall. In addition, during the last cycle of loading, *corner crushing failure* of the wall propagated, and it was more pronounced at the upper part of the infill wall than the lower part as shown in Figures 9F,G. In fact, some bricks at the upper right corner of the infill wall exhibited complete crushing with large portions of the material falling off. The ultimate failure mechanism also involved the shear failure of the upper ends of the columns (*short column mechanism*). The infill-column gap-opening measured during the last cycles of loading was in the range of 0.5–1.5 cm while the relative sliding between the infill-column interface was between 2.5–5 cm. The damage and crack pattern formed at the two sides of the specimen was practically identical.

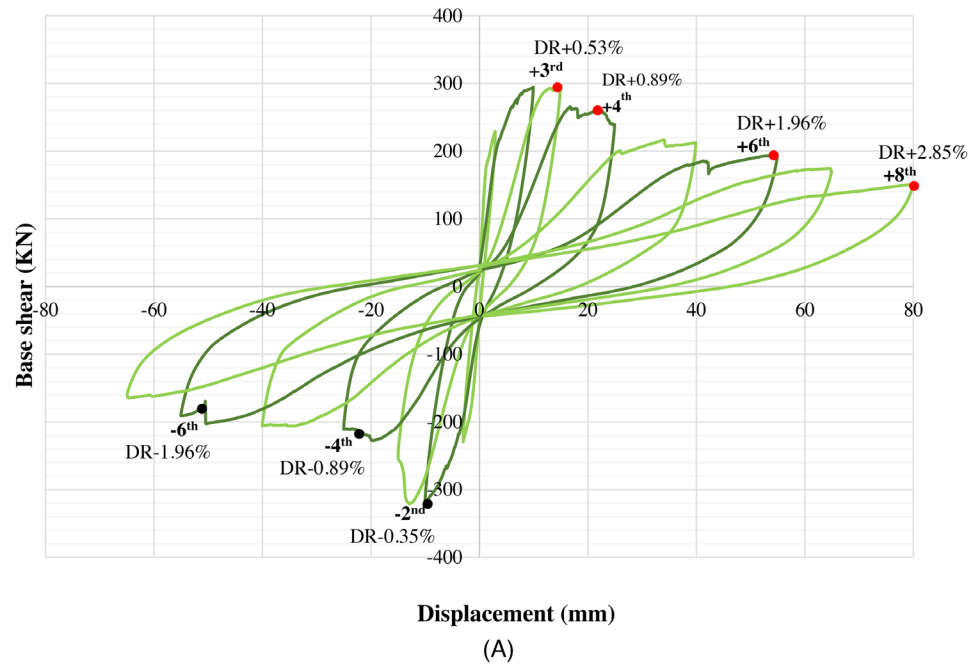
FIGURE 10 Response of M-XC specimen. (A) Base-shear versus top-floor displacement, (B) the crack patterns during the third cycle of loading, (C) second cycle of loading (negative direction), (D) during the fourth cycle of loading in the positive, and (E) negative direction, and during the sixth cycle of loading (F) positive and (G) negative direction.

Figure 10 presents the hysteresis curve and the progression of cracking at the unretrofitted side of the specimen for the second, fourth and sixth cycles of loading. In the positive direction, a maximum base-shear force equal to 296 kN was attained during the third cycle of loading when the displacement at the top of the specimen was 15 mm (drift ratio of +0.53%). In the negative direction a maximum load of -319 kN was recorded during the second cycle of loading corresponding to an imposed displacement of -10.3 mm (drift ratio of -0.35%). At the second and third cycle of loading in the positive direction, a step-type crack was formed at the lower part of the infill wall. This initiated at the mid-length of the wall's base and propagated toward the mid-height of right column as shown in Figure 10B. In addition, minor cracks developed at the lower corners of the infill wall. During the same cycles of loading, sliding cracks developed along the infill-column and infill-beam interfaces as shown in Figure 10B,C. At the fourth cycle of loading, when the imposed displacement was equal to ± 25 mm (drift ratio of $\pm 0.89\%$), the base-shear was equal to ± 225 kN which represents a 20%–25% decrease of the lateral resistance

The M-XC specimen (Figure 1) was subjected to seven and a half cycles of displacement-controlled loading before reaching a critical damage condition. The maximum imposed displacement in this case was equal to +80 mm (+2.85% drift ratio).

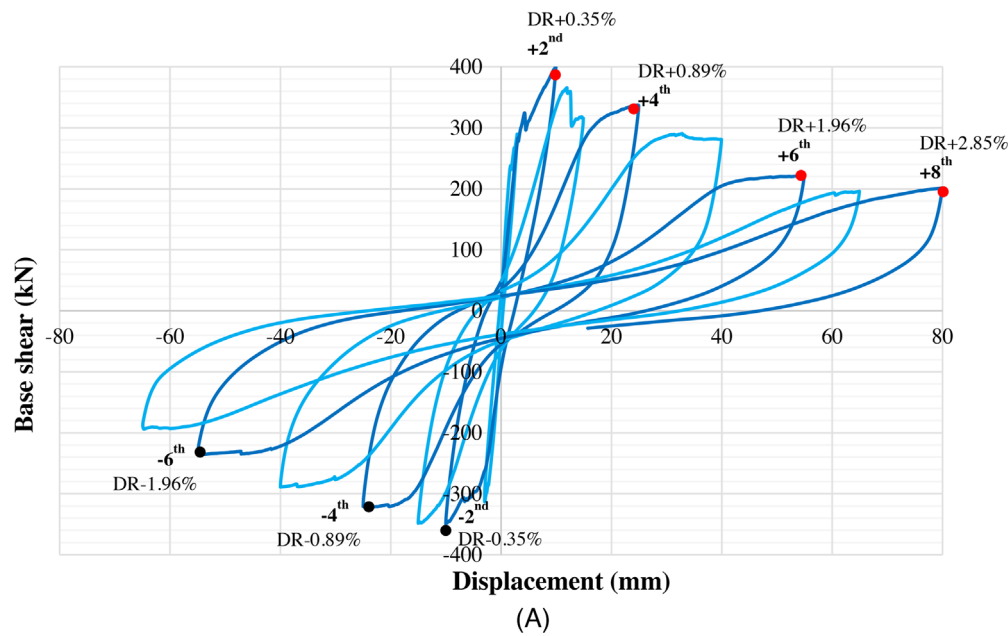
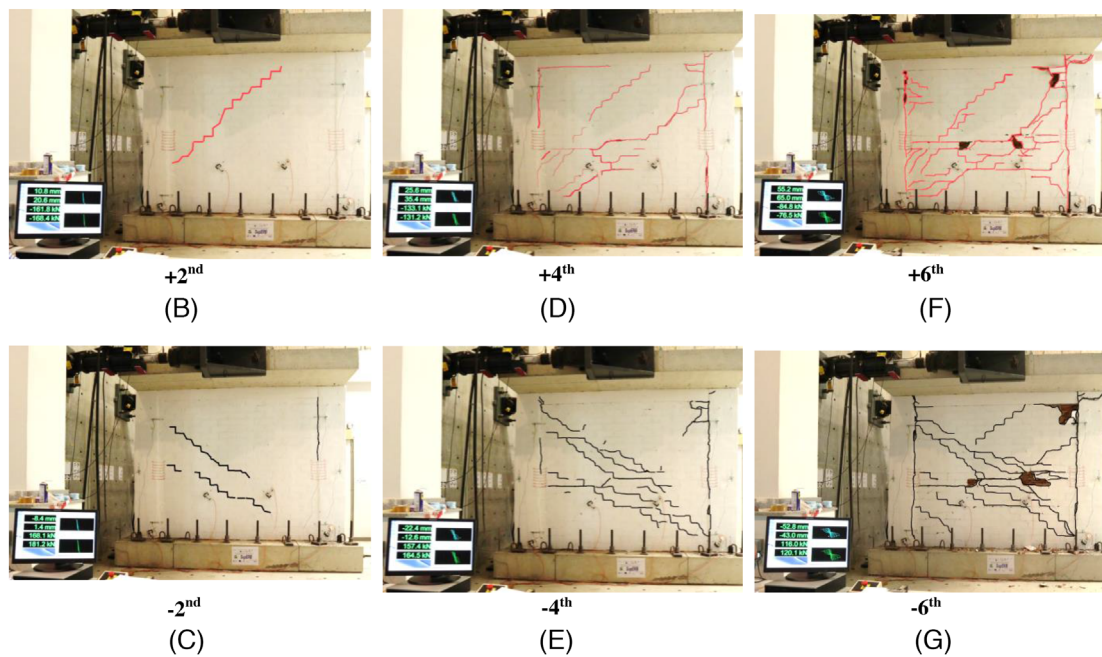
FIGURE 12 Response of M-CXC specimen. (A) Base-shear versus top-floor displacement, (B) the crack patterns during the second cycle of loading in the positive, (C) negative direction, (D) during the fourth cycle of loading in the positive, and (E) negative direction, and during the sixth cycle of loading (F) positive and (G) negative direction.

the progression of cracking at the unretrofitted side of the specimen for the second, fourth and sixth cycles of loading. The maximum base-shear force was attained during the second cycle of loading for both directions, and it was equal to 400 kN and -349 kN at corresponding top-displacements of 9.33 mm and -10.02 mm, respectively. During the second cycle of loading, step-type cracks were formed along the diagonals of the infill wall. One crack was observed when the loading was imposed in the positive direction (Figure 12B) and two cracks were observed when the loading was in the negative direction of (Figure 12C). At the same cycle of loading, minor sliding cracks also developed along the right column and the infill wall interface as indicated with black color in Figure 12C. At the third and fourth cycles of loading the base-shear force did not present a drop, unlike other specimens, and was on the average approximately ± 330 kN (both in the positive and negative directions) at a corresponding top-displacement of ± 15 mm (drift ratio of $\pm 0.53\%$) and ± 25 mm (drift ratio of $\pm 89\%$), respectively. This represents an 18% decrease in the positive direction and 5% decrease in the negative one of

the lateral resistance relative to the corresponding ones in the second cycle of loading. During these cycles of loading, the diagonal step-type and the sliding cracks that developed on the infill wall in the previous cycle of loading became wider and propagated throughout the entire surface of the masonry infill wall (spread along the diagonal of the infill wall) as shown in Figures 12D,E. Also, sliding cracks developed along the left column-infill wall interface and propagated to the lower part of the structure, below the mid-height of the column. Furthermore, the previously formed cracks along the right column-infill wall interface reopened, became wider and propagated along the full height of the right column-infill wall interface. As the displacement loading increased, a marked decrease of the lateral resistance and stiffness of the retrofitted infilled frame was observed. By the sixth cycle of loading, when a drift of $\pm 1.96\%$ was reached, the lateral resistance had dropped to ± 230 kN. At this cycle of loading, sliding cracks at the mid-height of the infill wall met the paths of the step-type cracks formed at previous cycles indicating the *diagonal cracking* combined with *sliding shear* failure of the infill wall. At the same time, the *corner crushing* failure became more pronounced since the bricks at the upper right corner of the infill wall exhibited crushing as shown in Figures 12F,G, while sliding cracks along the infill-column interfaces became wider indicating separation between the RC columns and the infill wall. Moreover, diagonal shear cracks that had developed during previous cycles of loading on the TRM layer covering the top-end of both RC columns became wider. This damage was more evident at the top-end of the right column and led to the rupture of the TRM at this location indicating the failure of the beam-column joint (*frame failure mode*). The test was intentionally terminated at the end of the seventh and one-half cycle of loading, at maximum-imposed displacement of approximately 80 mm (positive direction of loading) which corresponds to 2.85% drift ratio as shown in Figure 12A.

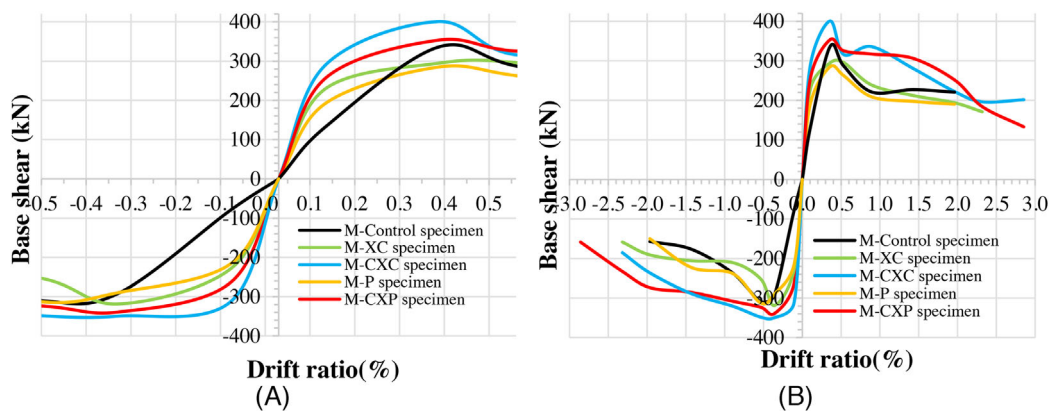
From Figure 18A it is observed that up to about a drift ratio of +0.2% or -0.3% in the negative direction the lateral resistance of the retrofitted infilled frames is higher than that of the control specimen (black line in Figure 18A), regardless of the retrofitting scheme. Moreover, a substantial increase is observed in the initial lateral stiffness that is calculated from the base-shear—displacement data of the first loading cycle (up to a drift ratio of $\pm 0.1\%$); see also Figure 20A. In all cases, the maximum base-shear force was attained during the second or third cycle of loading which corresponds to 0.35%–0.53%

FIGURE 18 Envelopes curves for all specimens in terms of base-shear versus drift ratio (A) until the third cycle of loading at the corresponding drift ratio of 0.53% and (B) total duration of the test.

drift ratio. Further comparison of the various schemes used is presented in Table 4. From Figure 18B it is observed that the drift ratio of the specimens retrofitted with two layers of TRM with or without PCMs is equal to 2.85%, which corresponds to a displacement capacity of +80 mm, while for the un-retrofitted specimen (M-control specimen, black line) it is equal to ±1.96% drift ratio (±55 mm displacement capacity). Thus, the displacement capacity of infilled frames increases by 45% by using two layers of TRM with or without PCMs. It can be also observed that the response of the infilled frame retrofitted with a single layer of TRM with PCM (M-P specimen, yellow line) is almost the same with the unretrofitted one (M-control specimen, black line) after the 0.35%–0.53% drift ratio.

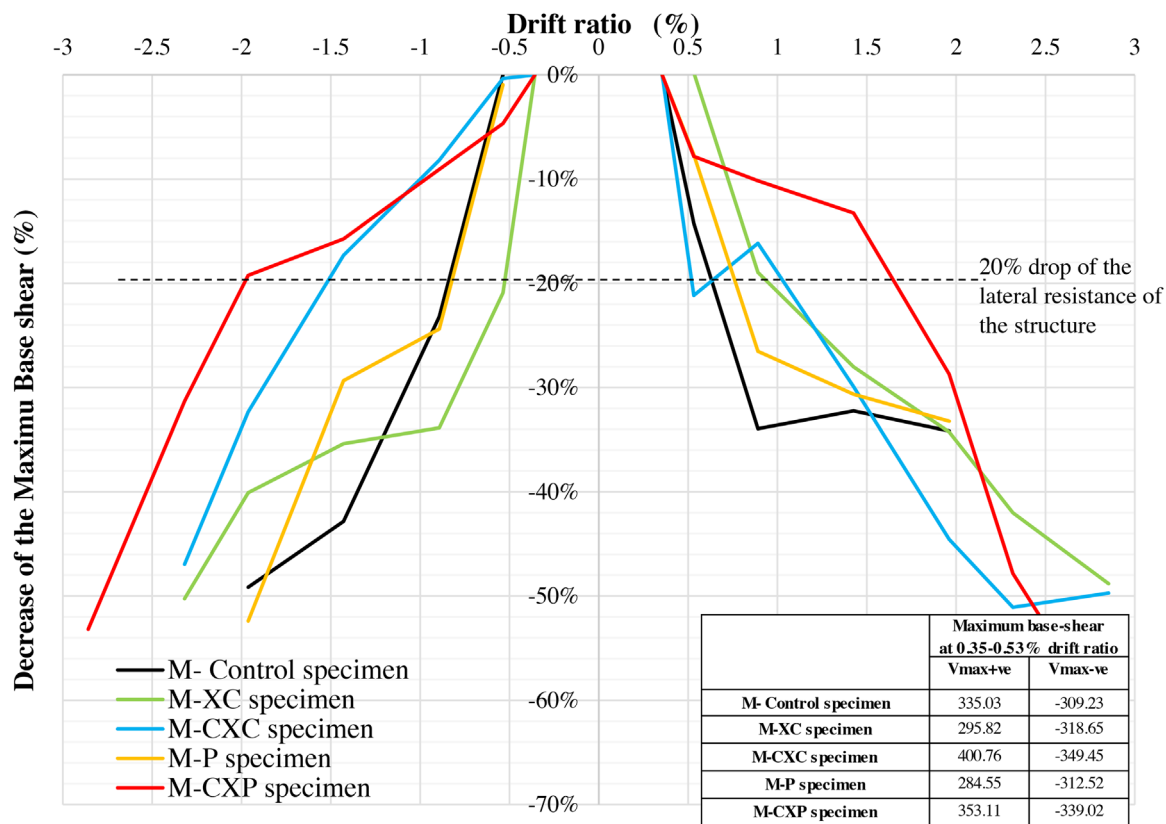
FIGURE 19 Decrease of the maximum base shear strength in relation to the drift ratio (after the peak).

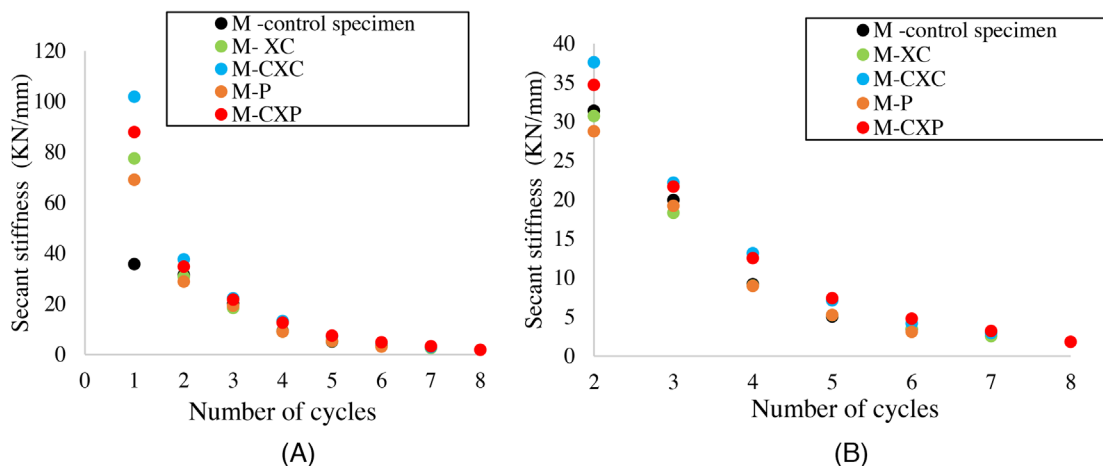
Figure 20 shows the global secant stiffness in relation to the number of cycles of loading and the secant stiffness after the second cycle of loading (after the 0.35% drift ratio) in relation to the number of cycles of loading. The secant stiffness degradation at the i^{th} cycle is calculated as follows (Equation (1)):

FIGURE 20 (A) Global secant stiffness in relation to the number of cycles of loading for all specimens and (B) global secant stiffness in relation to the number of cycles of loading after the second cycle of loading for all specimens.

From Figure 20A it is observed that the initial stiffness of the infilled frame is increased by applying either one layer or two layers of TRM. The initial stiffness of the M-CXC specimen, (green dots in Figure 20) and of the M-CXP specimen (red dots in Figure 20) is increased by about 185% and 94%, respectively, compared to that of the un-retrofitted specimen (control specimen, black dots in Figure 20). The initial stiffness of M-XC specimen (blue dots in Figure 20) and of the M-P specimen (yellow dots in Figure 20) is increased by 74% and 46%, respectively, compared to that of the un-retrofitted specimen. From Figure 20B it is observed that after the second cycle of loading which corresponds to 0.35% drift ratio, the secant stiffness of the M-XC specimen (green dots in Figure 20B) is almost the same as that of the un-retrofitted infilled frame (M-control specimen, black dots in Figure 20B) except at the third cycle of loading (which correspond at 0.53% drift ratio) where the secant stiffness of the unretrofitted specimen is slightly larger than that of the M-XC specimen. Also, from the second cycle of loading (which correspond to 0.35% drift ratio) and until the fourth cycle of loading (which corresponds to 0.89% drift ratio), the secant stiffness of M-CXC specimen (blue dots in Figure 20B) and of the M-CXP specimen (red dots in Figure 20B) is increased by about 11%–43% and by 5%–43% compared to that of the unretrofitted specimen. After the fourth cycle of loading until the end of the test the secant stiffens for all the specimens is almost the same and equal to that of the bare frame due to the failures that occurred in the infill walls.

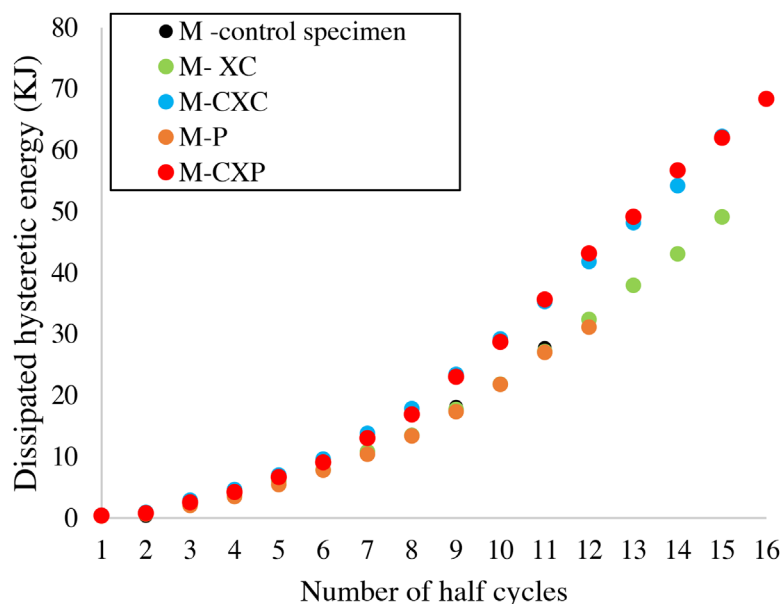
FIGURE 21 Dissipated energy in relation to the number of half-cycles of loading for all specimens.

From Figure 21 it is observed that at early stages of lateral loading (up to 0.53% drift ratio, which corresponds to six half cycles of loading) the dissipated energy is almost the same for all the specimens. After the 0.53% drift ratio the dissipated energy of the M-CXC specimen (green dots in Figure 21) and that of the M-CXP specimen, (red dots in Figure 21) is increased by 13%–63% and 20%–30%, respectively, compared to that of unretrofitted specimen (M-control specimen with black dots in Figure 21).

$$S_i = S_{i-1} + 0.5 * (V_{b,i} + V_{b,i-1}) * (X_{b,i} - X_{b,i-1}) \tag{2}$$
