CYPRUS UNIVERSITY OF TECHNOLOGY  
DEPARTMENT OF CIVIL ENGINEERING AND GEOMATICS

## **Postgraduate Thesis**

STUDY OF ASPHALT PAVEMENT DETERIORATION THROUGH  
REMOTE SENSING

Limassol 2016

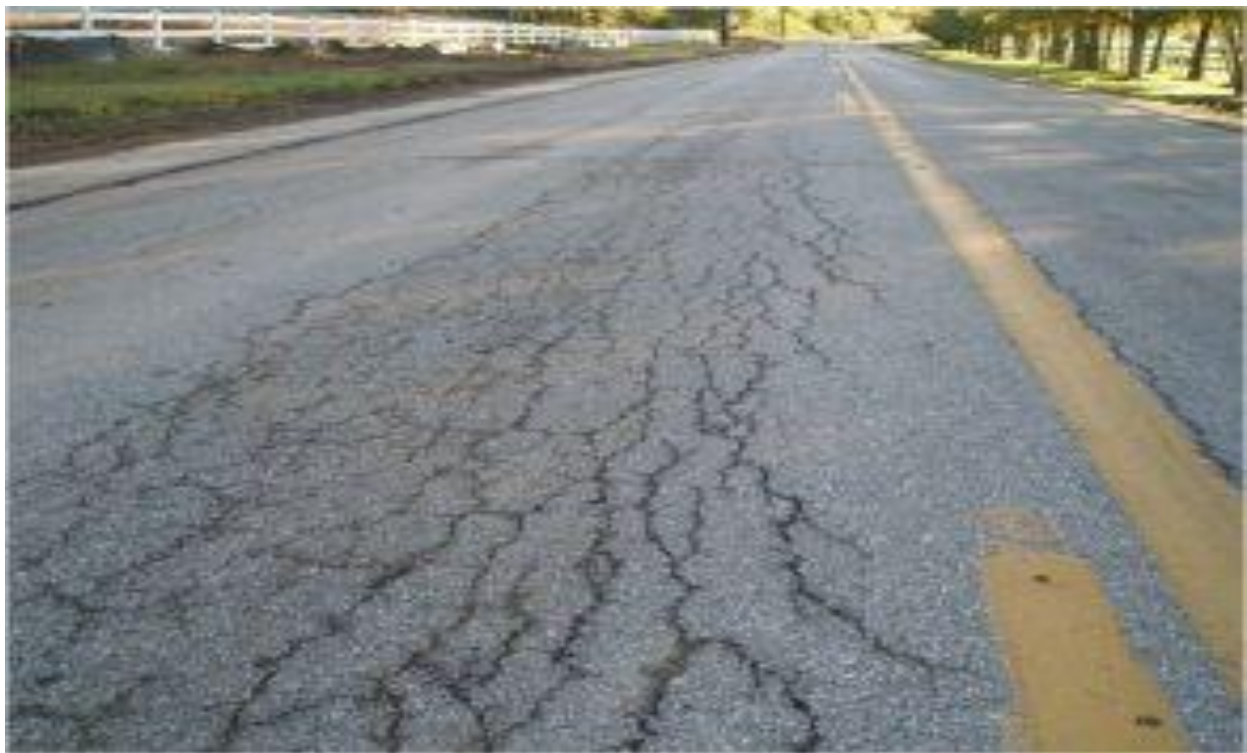
There are different types of cracks created on the asphalt pavements. Alligator cracking is type of crack that can be observed wherever in a road lane. It's a sequence of interconnected cracks of different stages of the development. Additionally, the alligator cracks expand into many sides, sharp-angled pieces and are more often observed to the longest side of the road lane (Miller, J. S., Rogers, R. B. and Rada 1993). This type of cracking occurs mainly to the roads with repeated traffic loads and is considered to be a parallel longitudinal crack due to the wheel path that expands with time and loads (Miller and Bellinger 2003).

Figure 1: Alligator cracking on asphalt pavement ([www.roadscience.net/node?page=2](http://www.roadscience.net/node?page=2)).

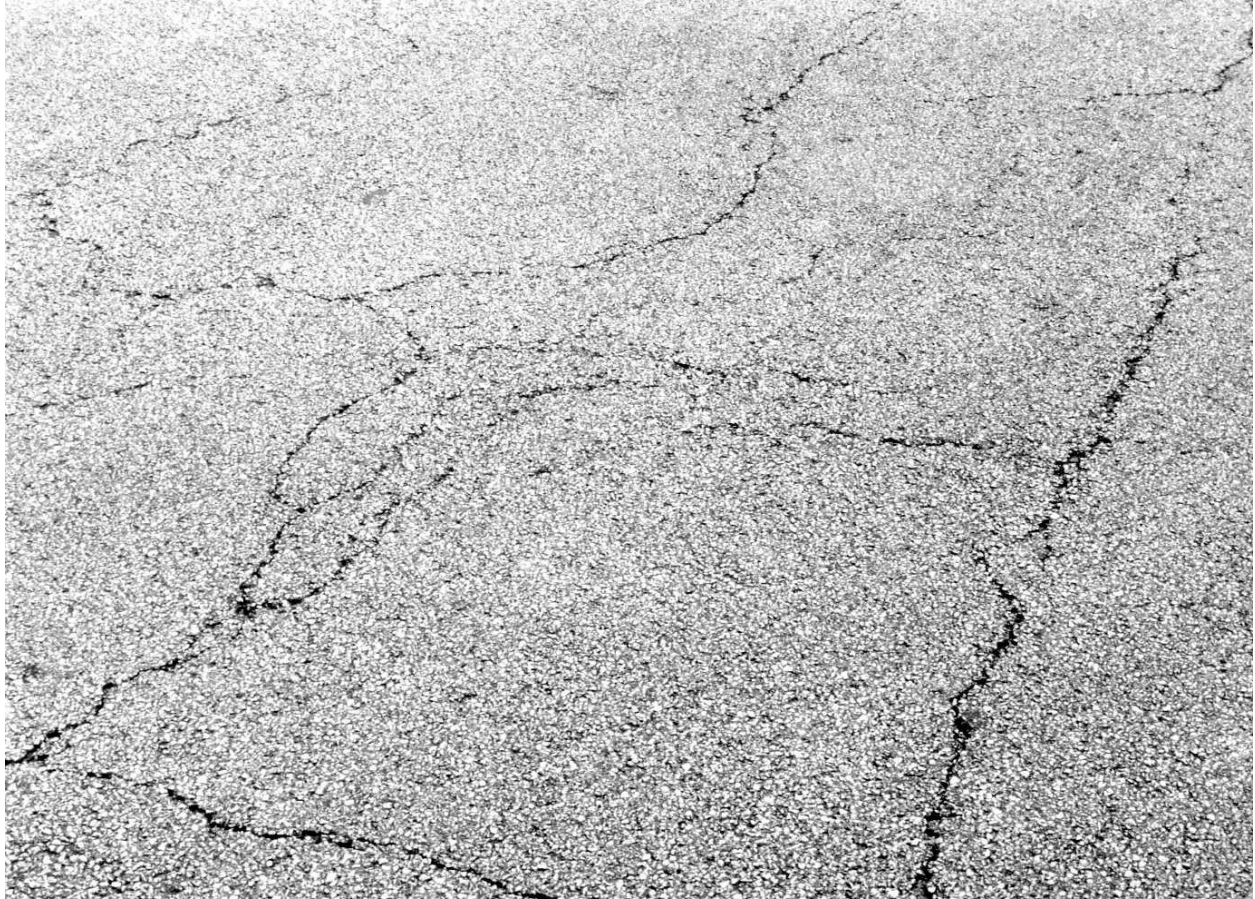
Block cracking is similar to alligator cracking although these types of cracks are divided into rectangular pieces which are usually classified as longitudinal and transverse cracking. The reasons of block cracking are the age of asphalt binder the poor mixture of the binder.

**Figure 2: Block cracking of asphalt pavement ([www.roadscience.net/node?page=2](http://www.roadscience.net/node?page=2)).**

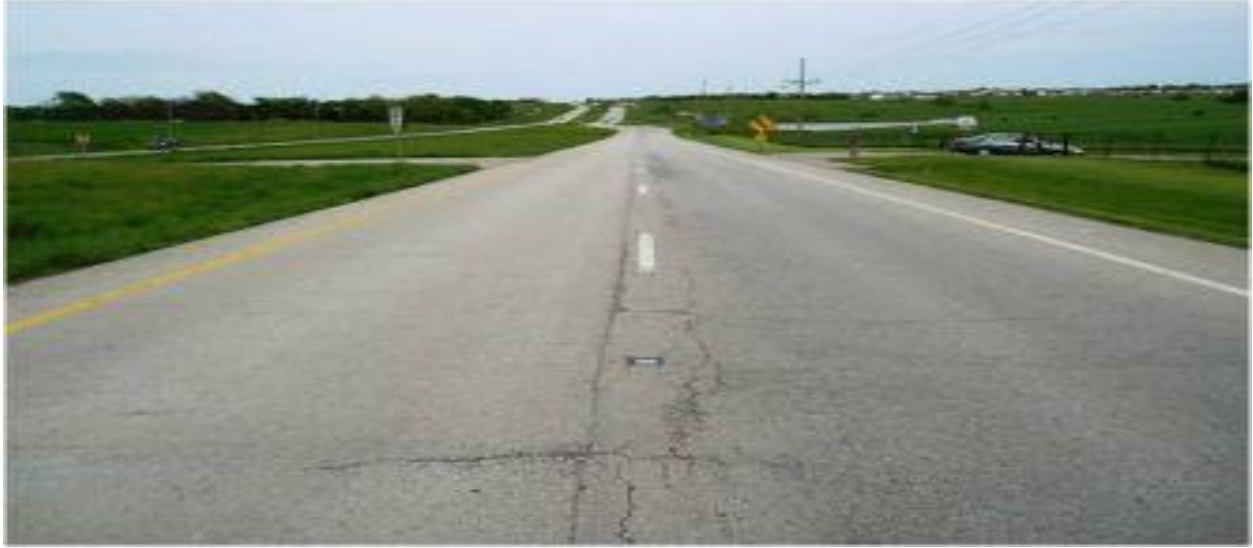
Longitudinal crack is running parallel to the centreline of the road. This type of crack is a wheel path versus non-wheel path which means it could be spotted anywhere within the lane (Federal Highway Administration 2009). Moreover, it is linked with the beginning of an alligator cracking. Additionally, these types of cracks are discontinuous, broken and they appear in the wheel path (Stein and Wressell 1999). Additionally, the reasons that longitudinal cracks occur are basically the shrinkage of the asphalt layer, cracks from the below layers which reflect up through the pavement and poor joint construction or location (Miller, J. S., Rogers, R. B. and Rada 1993).

**Figure 3: Longitudinal cracks in the asphalt pavement ([www.roadscience.net/node?page=2](http://www.roadscience.net/node?page=2)).**

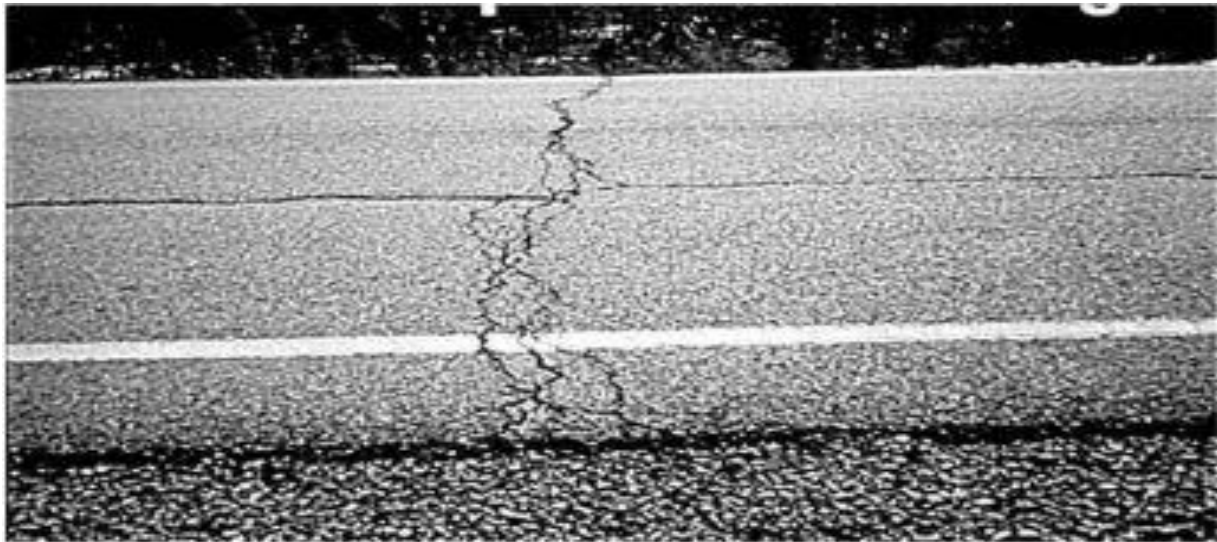
Transverse cracking is mainly perpendicular to the asphalt pavement centreline (Federal Highway Administration 2009). Also, transverse cracking can occur anywhere within the lane. The causes of transverse cracking are the paver blocks related to the incorrect set up, from the mixture of the asphalt, low temperatures and from cracks on the sub base of the pavement layers (Stein and Wressell 1999).

**Figure 4: Transverse cracking in the asphalt pavement ([www.roadscience.net/node?page=2](http://www.roadscience.net/node?page=2)).**

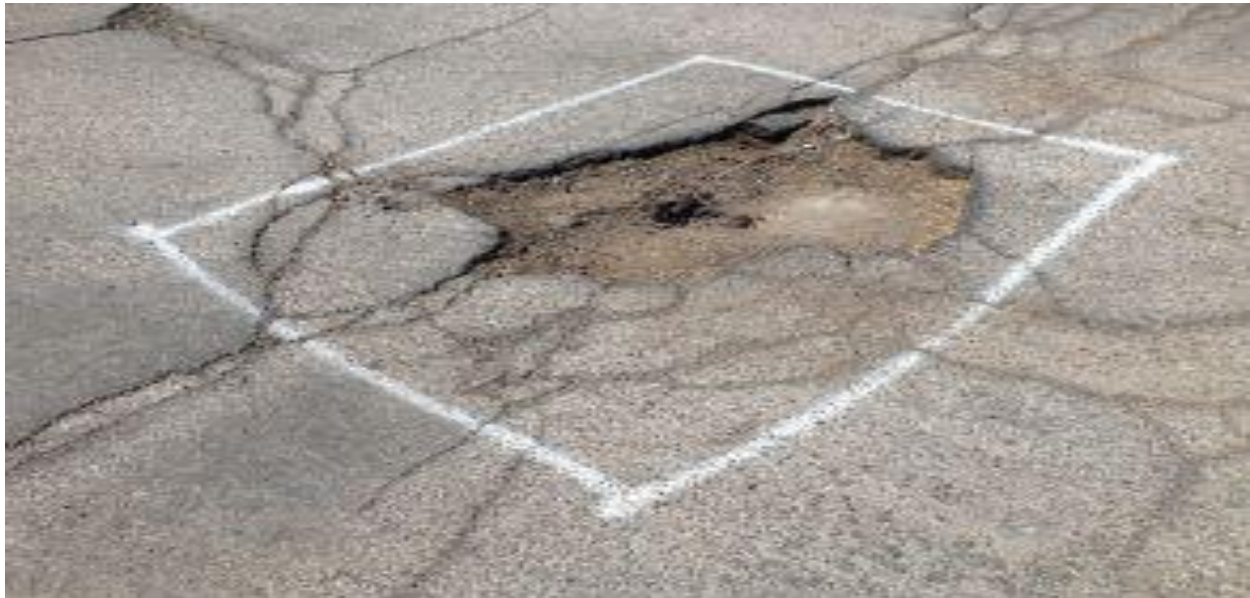
A pothole is a bowl-shaped hole which sometimes is created in more than one layer of the asphalt pavement. In other words, the hole in the asphalt surface penetrates all the asphalt layers to the base course. Potholes usually occur on the surfaces of hot asphalt mixture road and they are about 25mm to 50mm. Also the minimum diameter of pothole is 150mm (Miller and Bellinger 2003). The main reason that causes the pothole is when the water gets into the cracks and destroys the area below the cracks causing a pothole (Miller, J. S., Rogers, R. B. and Rada 1993). In addition some other causes of potholes are the weak subgrade, poor mixture of surface and the traffic. These can accelerate the potholes (Asphalt Institute 2016).

Figure 5: A pothole on the asphalt pavement ([www.roadscience.net/node?page=2](http://www.roadscience.net/node?page=2)).

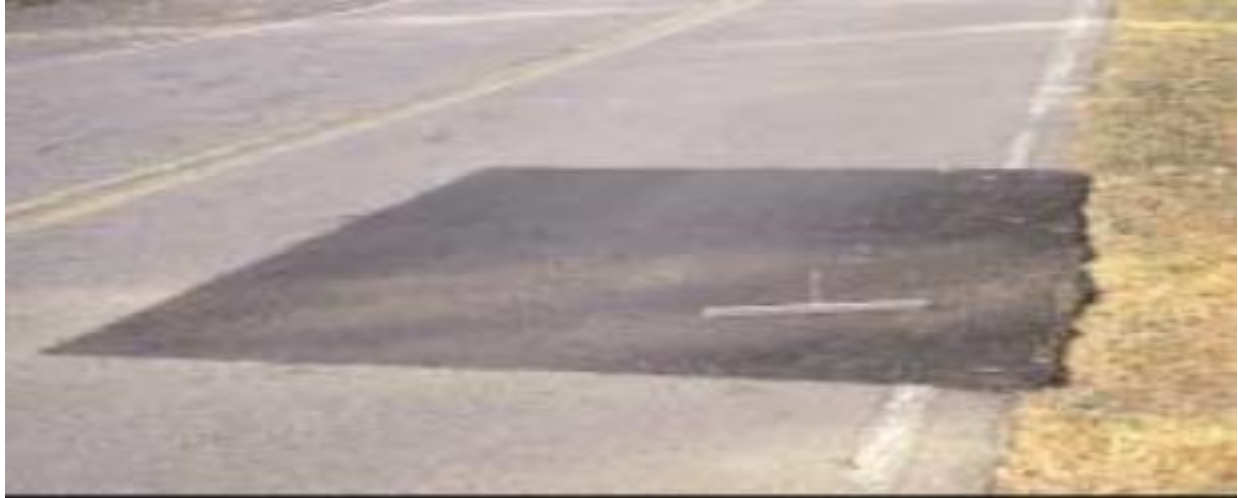
Patch/ Patch deterioration is the piece of asphalt pavement surface with area greater than  $0.1 \text{ m}^2$ , which has been removed and replaced or added material in the area of portion after the existing construction of asphalt pavement. The cause of deterioration of patches is the quality of asphalt mixture, poor construction and poor perimeter connection with the existing asphalt pavement. Also, may be appeal rutting settlement at the perimeter or in to the interior of the patch (Miller and Bellinger 2003).

Figure 6: Patch on the road pavement surface ([www.roadscience.net/node?page=2](http://www.roadscience.net/node?page=2)).

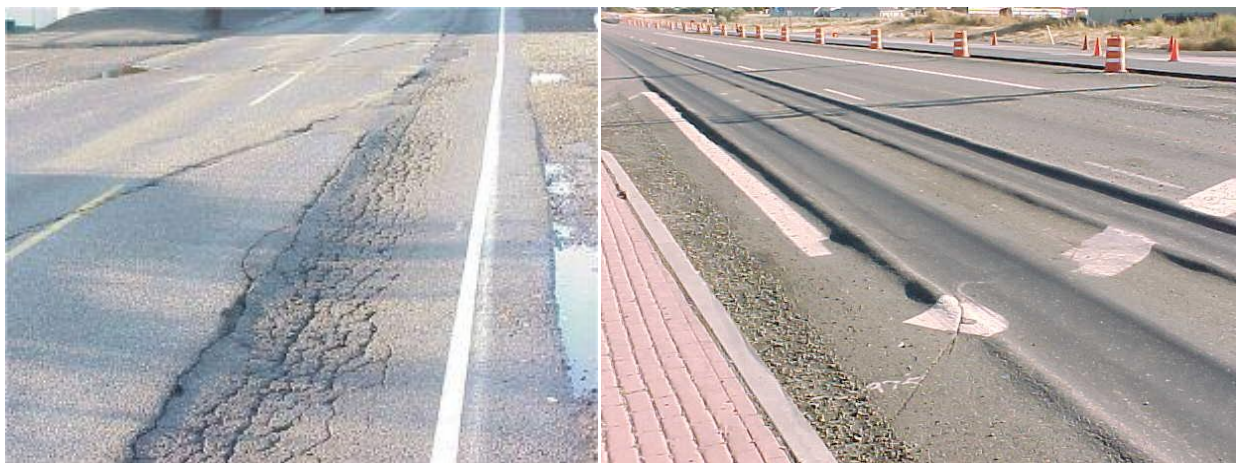
Rutting is a depression of the longitudinal surface in the wheel path, which can lead to other types of cracks and deteriorations of asphalt pavements. Additionally, rutting is the deformation of the road surface and the lateral movement of the materials due to traffic loads which appear mostly at braking and stopping traffic areas (Federal Highway Administration 2009). Mix rutting and subgrade rutting are the main types of rutting. In addition, parameters that affect rutting are feeble mixture of asphalt, thickness of layers, destruction of the pavement layers from moisture and lack of compaction (Asphalt Institute 2016).

Figure 7: The two types of rutting, on left the wheel path rutting and on the right severe mix rutting ([www.roadscience.net/node?page=2](http://www.roadscience.net/node?page=2)).

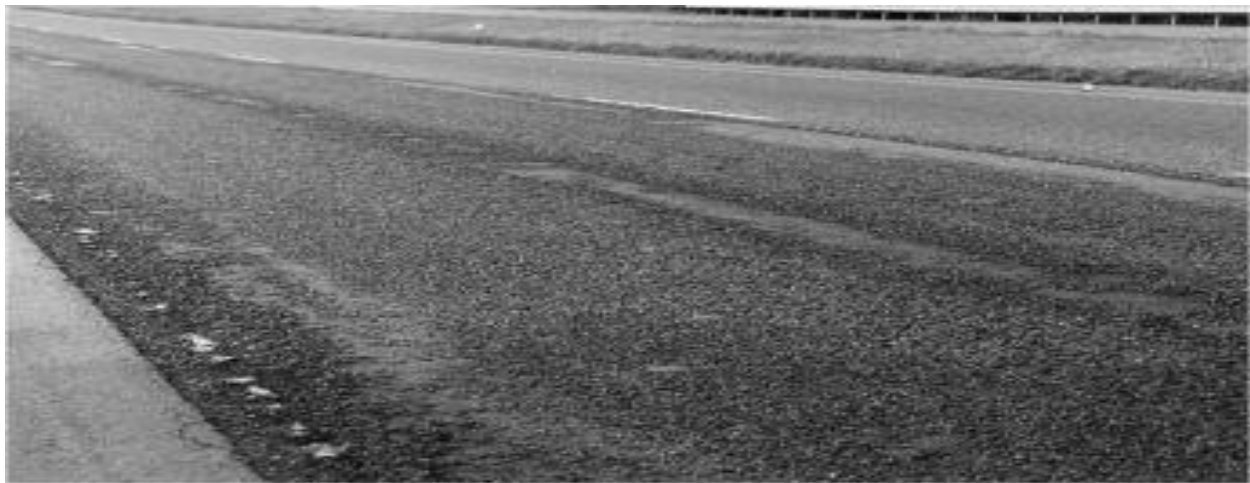
Raveling is the loss of the aggregate particles and asphalt binder. Due to weathering and raveling the asphalt binder loses the bond with the aggregate (Miller, J. S., Rogers, R. B. and Rada 1993). The roadway loses its smooth surface (Stein and Wressell 1999). The poor mixture quality of asphalt, the traffic, the water and asphalt hardening due to the aging of the asphalt pavements are the reasons of the raveling (Asphalt Institute 2016). Due to the high temperatures especially in the summer, the UV rays destroy this binder between them and cause the raveling on the surface.

**Figure 8: Raveling on the asphalt pavement ([www.roadscience.net/node?page=2](http://www.roadscience.net/node?page=2)).**

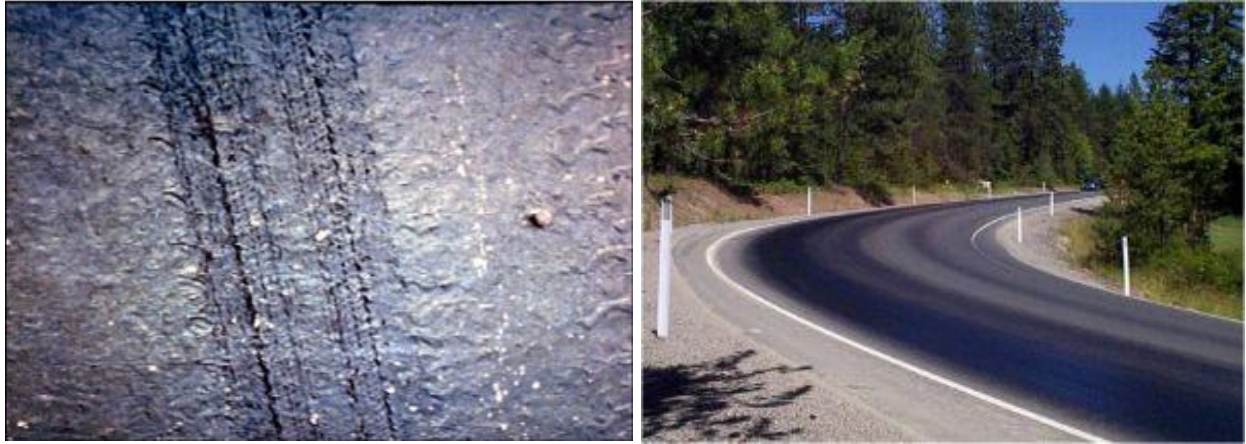
Blending and flushing are the results of the loss of surface texture on the asphalt pavement because of excess asphalt. Also, it is a shiny pavement surface due to the hot temperatures which is known as the reflective surface. Bleeding reduce the friction of the asphalt pavement and is therefore very important for the safety of the consumers (Miller and Bellinger 2003). Causes of bleeding and Flushing are too much asphalt into the mixture, improperly construction of seal coat and by using too heavy material into the mixtures (Asphalt Institute 2016). In general, flushing is the excess material of the asphalt bitumen rising on the surface and this is caused by a poor asphalt mix design.

**Figure 9: Bleeding and flushing on the asphalt pavement ([www.roadscience.net/node?page=2](http://www.roadscience.net/node?page=2)).**

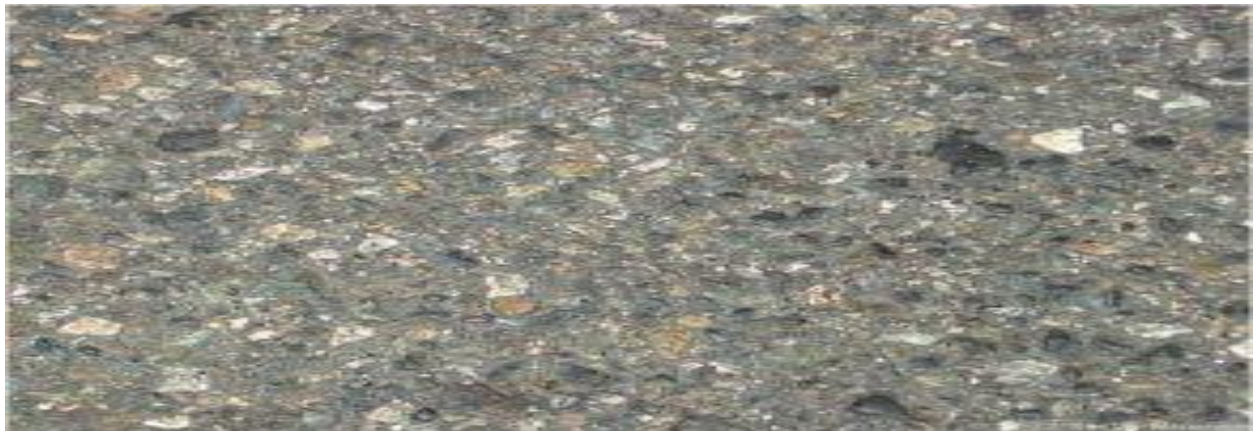
Polished aggregate is the worn away of the bitumen of the mixture to expose coarse aggregate (Miller and Bellinger 2003). The possible cause of polished aggregate is the use of soft aggregate that polish quickly under the traffic and the surface loss its macro texture as well as the surface sooth and rounded (Asphalt Institute 2016).

**Figure 10: Polished aggregate on the asphalt pavement surface ([www.roadscience.net/node?page=2](http://www.roadscience.net/node?page=2)).**

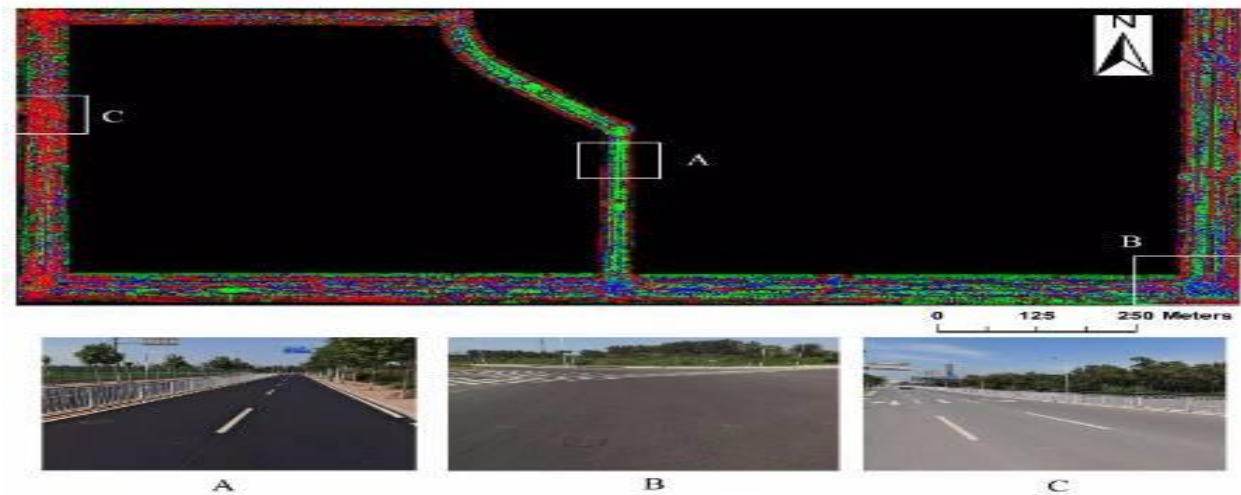
images they classified as preliminary aging (green), moderately age (blue) and late aging (red). The following figure (Figure 11) shows the GPR image and the classification of the ageing of the road as green, blue and red. The main conclusion from this study was that the age of each road characterised from its own spectral feature. Using World View-2 and MESMA, found to be a useful tool, which it can be used by the authorities for road maintenance. The researchers of the study suggested that higher spectral resolution and wider band coverage would be better for this study and for future studies.

**Figure 11: RGB image for the classification of the ageing of the road (Pan et al. 2016).**

Pan et al. (2016), studied about the road pavement condition mapping by using remote sensing data based on Multiple End member Spectral Mixture Analysis (MESMA). The detection of the pavement conditions due to the roads life (different ages) was the main purpose in this study. First, they used spectrometer to take field spectral measurements and then with the use of World View-2 high resolution images, they covered the on-site area. By using MESMA and RGB
