Chapter from the book *Integrated Use of Space, Geophysical and Hyperspectral Technologies Intended for Monitoring Water Leakages in Water Supply Networks* Downloaded from: http://www.intechopen.com/books/integrated-use-of-space-geophysical-and-hyperspectral-technologies-intended-for-monitoring-water-leakages-in-water-supply-networks

Introduction

Skevi Perdikou, Kyriacos Themistocleous, Athos Agapiou and Diofantos G. Hadjimitsis

1. Introduction — The problem of water leakages

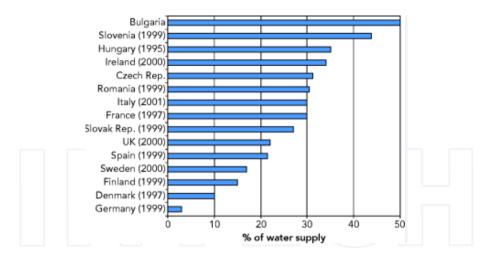
Figure 1. Losses from urban water networks. (): Year of data. (http://www.eea.europa.eu/legal/copyright). Copyright holder: European Environment Agency (EEA, 2008).

A significant amount of water is lost in the water supply system. Water leakages have been a major problem for many regions around the world (Weifeng et al, 2011). In some countries water loss due to water leakages in the supply network exceeds 40% of the water in the supply system (Fig 1). Reduction of water leakages is an important goal for many countries in the world (Vairavamoorthy and Lumbers, 1998), as it will mean a reduction in the amount of money and energy required on producing and pumping water and also satisfaction of consumer needs through improved reliability of the system (Ayala–Cabrera et al, 2013).

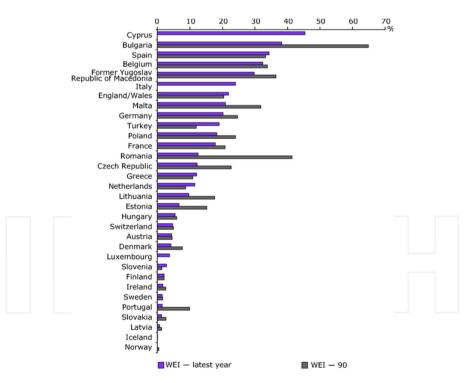
Figure 2. Total water abstraction per year as a percentage of the total long-term renewable resource. (http:// www.eea.europa.eu/legal/copyright). Copyright holder: European Environment Agency (EEA, 2008).

The Eastern Mediterranean countries are expected to be affected adversely by climate change. Similar to other countries in this region, Cyprus has semi-arid climate with limited water resources (Zachariades, 2010). This, combined with the high water demand on the island, resulted in Cyprus having the highest Water Exploitation Index across Europe WEI (Fig 2). A WEI above 20 % implies that a water resource is under stress and values above 40 % indicate severe water stress and clearly unsustainable use of the water resource (Raskin et al., 1997).

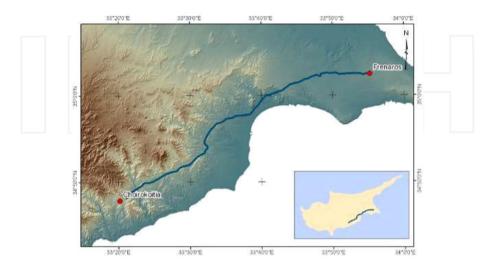
Figure 3. The "Choirokoitia-Frenaros" water pipe

In order to identify and monitor water leakages, 3 case studies are described in this section: (a) Frenaros-Choirokoitia (b) Lakatamia and (c) Germasogeia water pipe network. The first case study Frenaros-Choirokoitia (Fig 3) is a major rural pipeline in Cyprus, which runs from the *Choirokoitia* area to the *Frenaros* area. The existing pipeline, which passes through the central and central-east part of Cyprus, has a length of over 65 km. The pipeline is located 1-3 meters below ground surface. Various geological formations, generating several soil types including calcaric cambisols, calcaric regosols, and epipetric calcisols, exist in the area, while the higher

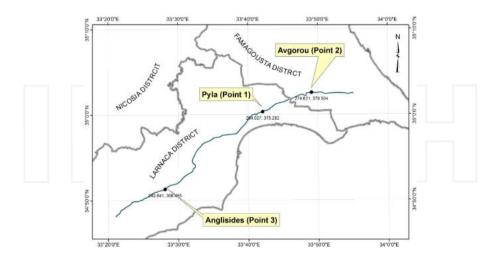
Figure 4. Points 1-3 indicate the spots were water leakages have been reported in the "Choirokoitia-Frenaros" water pipe.

and lower elevation of the pipeline (ground surface) is estimated to vary between 10 m and 200 m above sea level. From 2007 to 2010, three major leakages were observed along different sections of the pipe (Fig 4). The locations of these leakages were not detected at once after the leakage occurred. The leakages occurred during 2007, 2008 and 2010; further details for these events are described later in the book.

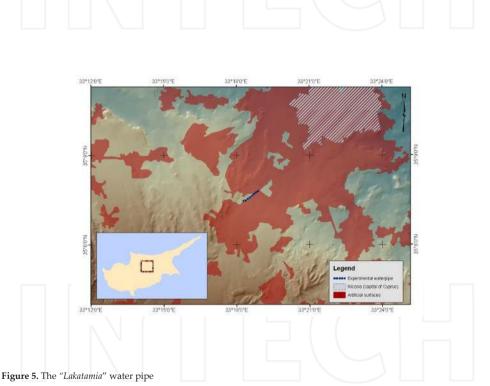
The Lakatamia water pipe (Fig 5) has a length of less than 5 km and has been systematically reported as problematic due to several leakages and it is therefore no longer in use by the local authorities. The pipe runs through urban and rural areas. A section of the pipeline, with a length of over 2km and located in a rural area, has been used for the detection of leakages. Since the existing water pipe is not currently in use, it was necessary to fill the pipe periodically with water to observe the effectiveness of such remote sensing non-contact techniques. The water pipe is made of UPVC and has 315mm diameter. It is between 1.80m and 2.00m below the ground surface and runs along the *Pediaos* River for a large part of its length. It is currently not being used due to water leakages occurring throughout almost the entire length of the pipeline. Information regarding the specific dates of events is not available from local authorities.

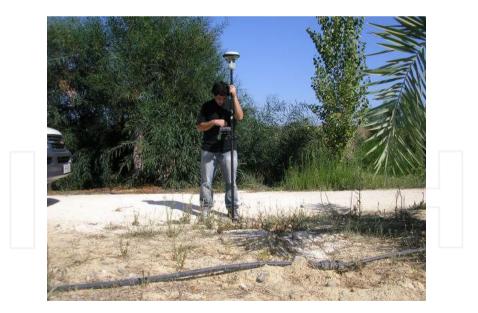
Figure 6. GPS measurements in the Lakatameia pipeline.

For all three case studies, the first step was to georeference the water pipes under examination. For the "Chroirokoitia-Frenaros" water pipe, all data regarding the characteristics of the pipeline were collected in CAD format from the Water Development Departmentwhich is the responsible authority for the water pipe. In addition, the coordinates of the leakages were collected and added in a GIS environment. The GIS environment allows the researchers to identify potential areas which are suitable for the detection of the event, so they can be identified on satellite images. Soil, land use and meteorological data were also included in the GIS environment. A similar approach was followed for the "Germasoyeia-Moutagiakia" pipe line. The CAD file was converted into a :shp file and imported into a GIS database. For the pipeline in the area of Lakatameia, GPS measurements were carried out to map the path of the pipeline (Figure 6; Figure 7). Engineers from the municipality of Lakatameia also indicated problematic spots over the buried pipeline, which were recorded in the data. Figure 7 shows the pipeline as mapped from the GPS measurements (with red line, background Google Earth).

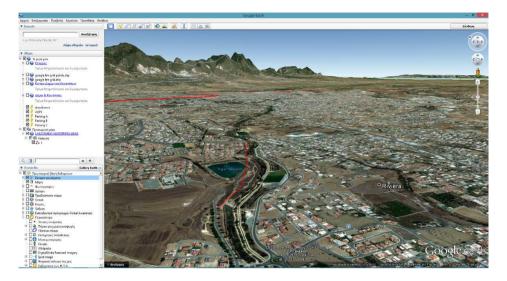
Figure 7. Pipeline as mapped from the GPS measurements (with red line, background Google Earth).

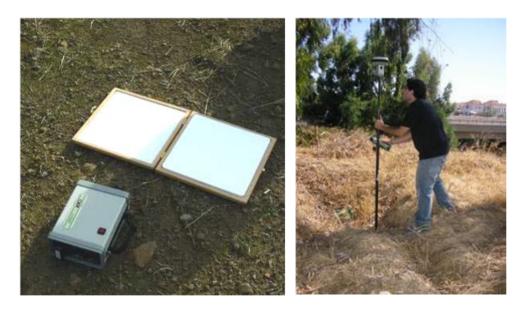
Figure 8. a) (left): The GER 1500 spectroradiometer used for the collection of ground measurements and b) (right): the GNSS used for mapping the pipeline

In order to avoid any errors due to changes in the prevailing atmospheric conditions (Milton et al. 2009), the measurements over the panel and the target were taken within minutes of each other. The coordinates of the measurements were mapped using a Global Navigation Satellite Systems (GNSS) (Figure 8b).

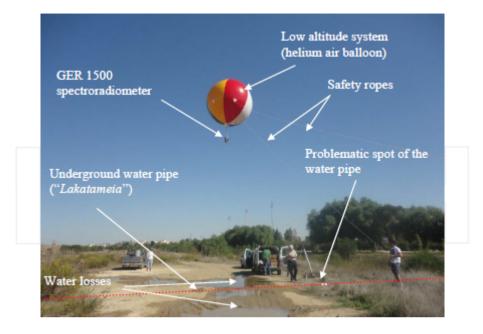
Figure 9. The low altitude system for spectroradiometric data

In addition, spectroradiometric measurements were taken from a low altitude system (Figure 9). The spectroradiometer was attached to the air balloon and raised over the pilot study area. Measurements were taken at several heights in the pilot study area and also in the surrounding area in order to compare their spectral signature profiles. As the airborne system was raised, the pixel size of the ground increased.
