Chapter from the book *Integrated Use of Space, Geophysical and Hyperspectral Technologies Intended for Monitoring Water Leakages in Water Supply Networks*  
Downloaded from: <http://www.intechopen.com/books/integrated-use-of-space-geophysical-and-hyperspectral-technologies-intended-for-monitoring-water-leakages-in-water-supply-networks>

# Investigation of Ground Remote Sensing Techniques for Supporting an Early Warning Water-Leakage System

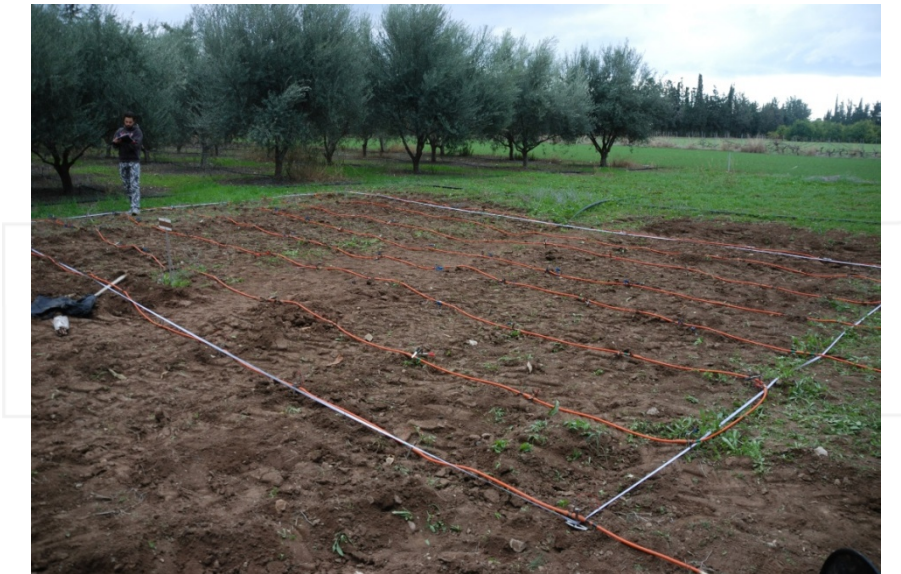
**Figure 1.** Area of interest. A pipeline was buried at a depth of approximately 1 meter.

In this area, a pipeline was buried 1 meter below surface. Cracks were produced in the pipeline in order to create an artificial leakage event. The end of the pipeline was connected to a valve. Figure 2 shows the area of interest approximately one hour after the artificial leakage event.

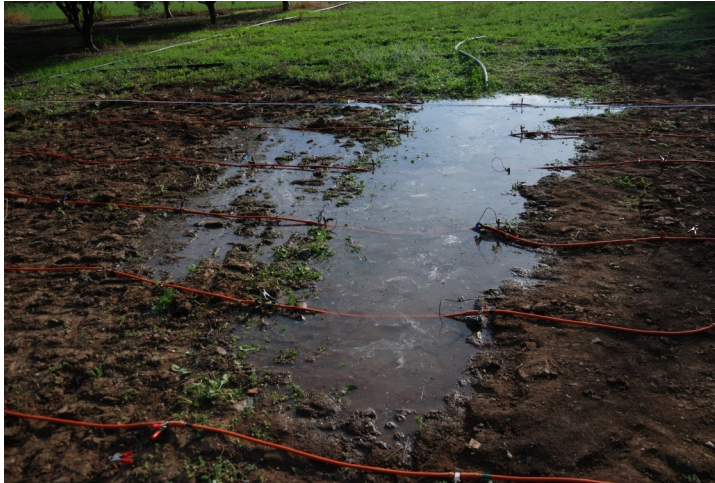
Figure 2. Leakage as observed from the surface

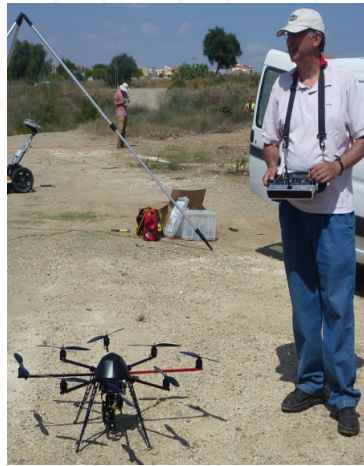
Figure 3. Oktocopter UAV

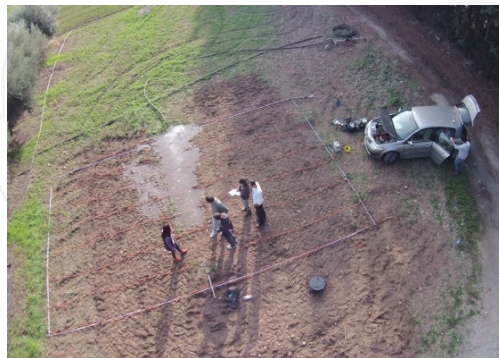
Figure 4. Leakage event in Mandria as observed from UAV

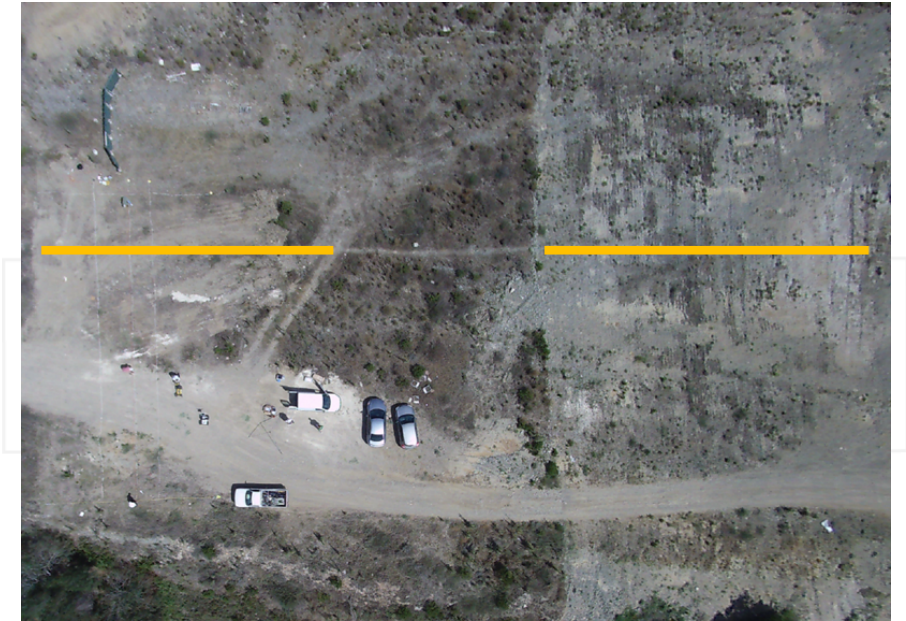
**Figure 5.** Lakatameia underground pipeline as observed from UAV

It was found that, in some cases, the UAV can identify water leakages and water pipelines in different ways such as increased vegetation along the pipeline where the water leakage occurs, change of soil characteristics along the pipeline route (Figure 5), as well as changes in the reflectance value of soils in the water leakage area. UAVs can also be used with thermal and infrared cameras to identify changes in temperature due to water leakage. An additional benefit of UAV platforms is that they can be used to survey large areas to provide overall coverage of the area or it can be used for areas that are inaccessible. The integration of UAV with other techniques is a useful method to cross-validate the leakage event.

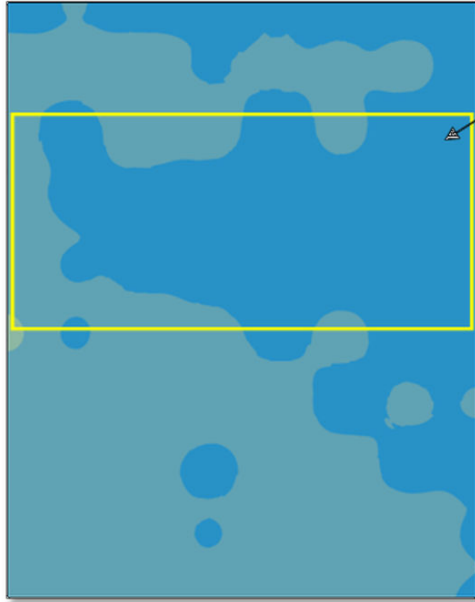
**Figure 6.** Ground temperature over the area of interest as recorded from the digital laser thermometer, before the leakage event. Rectangle indicates the location of the buried pipeline. Blue values indicates temperatures 14-16°C while the cyan colour temperatures 16-18°C.

Figure 6 indicates the results from the ground temperature measurements before the leakage event. The results show that the minimum temperature values are recorded around the pipeline. This is most likely due to the presence of soil moisture resulting from a prior leakage, which occurred a month prior to the measurements. Similar results were also observed in the top of Figure 6, since the olive trees present in the area tend to hold moisture in the soil. In comparing the soil temperature over the pipeline against surrounding area, a relative differ-

ence of 2 °C was observed. This difference is logical, since from the last leakage event the soil temperature tends to be close to its original (background) value.

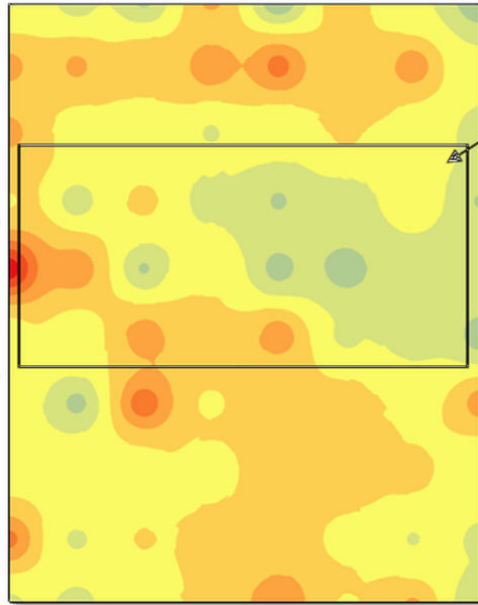
**Figure 7.** Ground temperature over the area of interest as recorded from the digital laser thermometer, during the leakage event. Rectangle indicates the location of the buried pipeline. Blue values indicates temperatures 14-16°C, 24-26°C are shown in yellow while orange colour highlight values from 34-36°C

Figure 7 demonstrates the results during the leakage event. The lowest surface temperature is shown in the western part area over the pipeline. In this section, the leak was initially observed during the leakage event. The soil temperature for the rest of the area was relatively high. These values indicate that moisture was not detected. The soil temperature also indicated a relative difference of about 6 °C of the leakage event and the rest dry area. Figure 8 features a photograph taken during the leakage event, as well the results from this area. The temperature measurements were able to map the problematic area with high accuracy and thereby define the leakage event. After the leakage event, the soil temperature decreased in the area over the buried pipeline. As shown in Figure 9, the entire pipeline had a tendency to present lower temperature values, including the leakage zone. The difference recorded in this step was estimate to be 8°C.

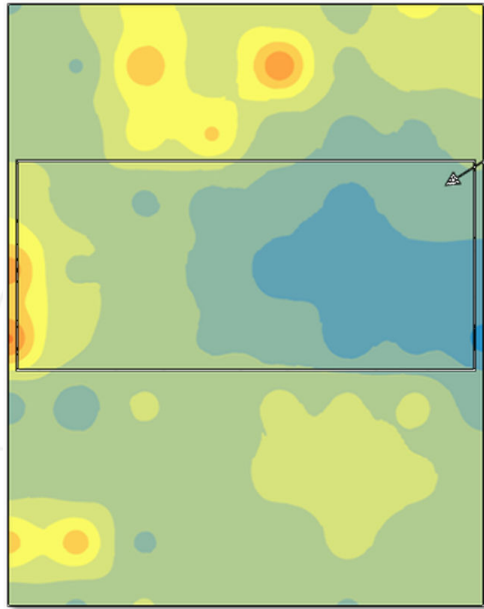
**Figure 9.** Ground temperature over the area of interest as recorded from the digital laser thermometer, during the leakage event. Rectangle indicates the location of the buried pipeline. Blue values indicates temperatures 14-16°C, 24-26°C are shown in yellow while orange colour highlight values from 34-36°C

In comparing the above figures, it appears that the soil temperature over the buried pipeline provided lower values before, during and after the leakage event. The relative temperature difference in this zone in relation to rest of the study area was initially small, then subsequently decreased and finally further decreased. The relative difference temperature of this zone prior to and after the leakage indicates a 60% reduction in relation to the surrounding area.

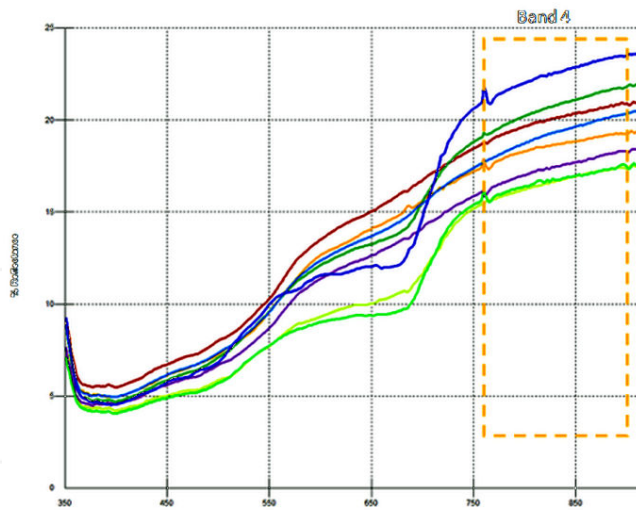
**Figure 10.** Spectral signatures profiles before and after the leakage event. The differences are maximized in the near infrared part of the spectrum (Band 4)

Figure 10 features the spectral signatures profiles from some regions of the study area before and after the leakage event. Using this figure, some preliminary conclusions can be drawn in relation with the reflectivity values of the same regions prior and after the leakage. The near infrared part of the spectrum (Band 4) tends to give the highest deviations. The reflectance values after the leakage is lower than prior to the event. Regarding the measurements over the pipeline there is a difference in the reflectance values before and after the leakage (spectral signature red and yellow).

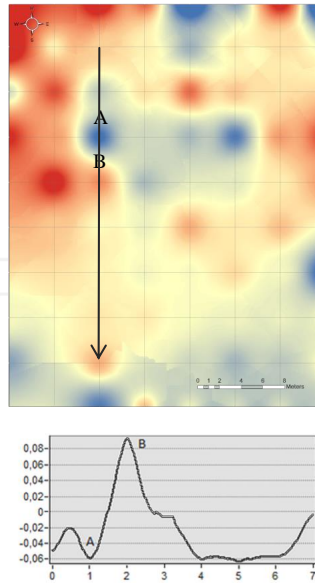
**Figure 12.** Difference values as calculated for RDVI index (before and after the leakage). A cross section passing through the pipeline (A-B) is also drawn.

are observed in the area over the pipeline. In order to create this map, the EVI index was calculated before and after the leakage event and then these two indexes were subtracted. In a similar manner, the RDVI index was also able to show this leakage. A cross section from North to South was performed to see the vertical profile of the index. As demonstrated in Figure 12, the highest difference is recorded as the section pass through the pipeline (points A and B in Figure 12).

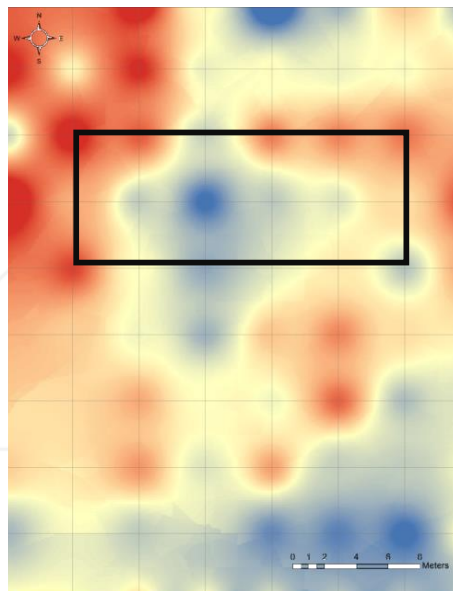
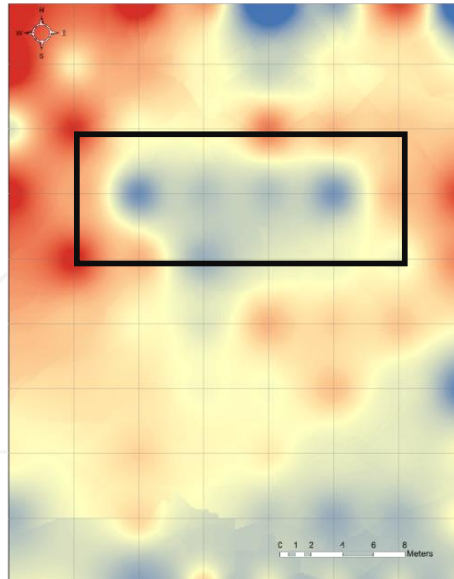
**Figure 13.** Difference values as calculated for SRxNDVI index

Figure 14. Difference values as calculated for SR index

Figure 15. Difference values as calculated for SARVI index

**Figure 16.** Difference values as calculated for RVI index

**Figure 17.** Difference values as calculated for OSAVI index

Figure 18. Difference values as calculated for NDVI index

Figure 19. Difference values as calculated for MSR index

Figure 20. Difference values as calculated for MSAVI index

Figure 21. Difference values as calculated for IRG index

Figure 22. Difference values as calculated for GNDVI index

Figure 23. Difference values as calculated for GEMI index

Figure 24. Difference values as calculated for DVI index

Figure 25. Difference values as calculated for ARVI index

Several vegetation indices presented in Figures 13-25 were able to highlight the leakage as well as the area around the buried pipeline before and after the leakage (table 2). The buried pipeline is indicted by the black triangle in each figure. However, in addition to the leakage event, there were other parameters that played a significant role for the detection of the problem. As the results indicate, vegetation indices, including the NDVI index, were able to identify the leakage, yet there were some problems related to the atmospheric conditions. In contrast, the ARVI index was able to map the leakage with no difficulties since it is an atmospheric resistance index. EVI was another index with can be applied for this purposes as well.

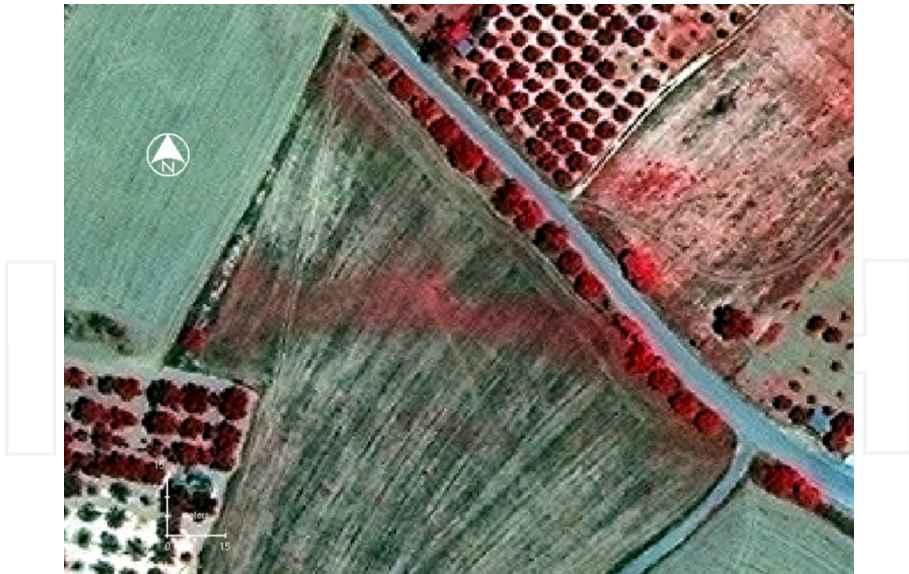
**Figure 27.** Detection of leakage problem using high resolution satellite data (Agapiou et al. 2014)

The modeler was built into the ArcGIS environment and successfully applied using several satellite data. Previous studies of the authors (Agapiou et al. 2014) the detection of leakage events was possible (see Figure 27).
