Detection of Water Pipeline Leakages Using High-Resolution Satellite Imagery and Auxiliary Ground Data in Cyprus. Case study of Community Councils of Doros and Monagri.

Christos Theocharidis^{1*a,b}, Christiana Papoutsas^{a,b}, Kyriacos Themistocleous^{a,b},
Christodoulos Mettas^a, Diofantos Hadjimitsis^{a,b}

^aERATOSTHENES Centre of Excellence, Franklin Roosevelt 82, 3012 Limassol, Cyprus.

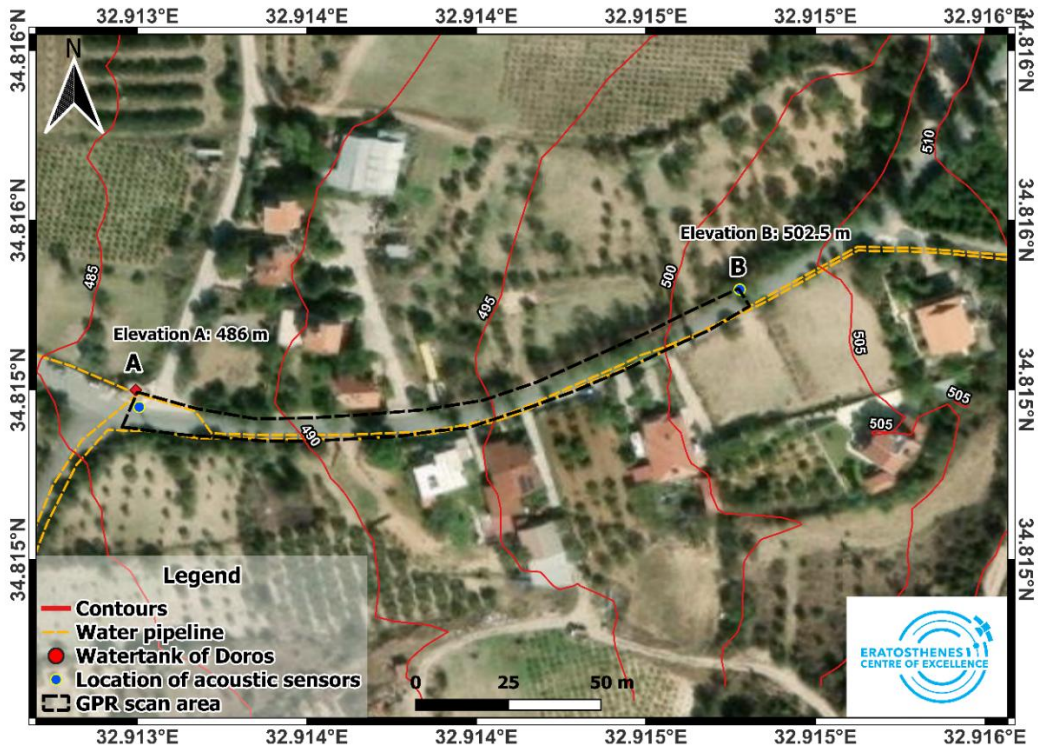
Figure 6. The GPR survey carried out on a selected road in Doros village.

The survey design followed a systematic strategy to maximise coverage and ensure redundancy for anomaly verification. As shown in Figure 6, the GPR survey was conducted along the pipeline route between point A (elevation 486 m) and point B (elevation 502.5 m). The survey targeted a potable water main running along the primary road where leakage was suspected. Parallel and cross-line acquisition geometry was adopted to (i) resolve pipe position and depth through hyperbola apex picking along the alignment and (ii) confirm potential anomalies across the alignment where leakage plumes may spread laterally through permeable backfill. Previous work highlights that combining orientations improves utility detection and localisation in traffic corridors. Data collection was performed reciprocally, beginning at point A, moving towards point B, and returning along the same path. The process was repeated nine times in total, deriving nine profiles of the road in the end. The bidirectional acquisition strategy helped reduce directional bias, ensured consistency of detected features, and improved confidence in identifying persistent anomalies. To further constrain the lateral extent of potential leakage zones, parallel to the road transects (profiles P1–P9) were acquired across the road surface (Figure 7). Together, the longitudinal and perpendicular profiles created a dense grid of measurements, improving the spatial coverage of the survey and allowing a more robust interpretation of subsurface anomalies potentially related to leakage.

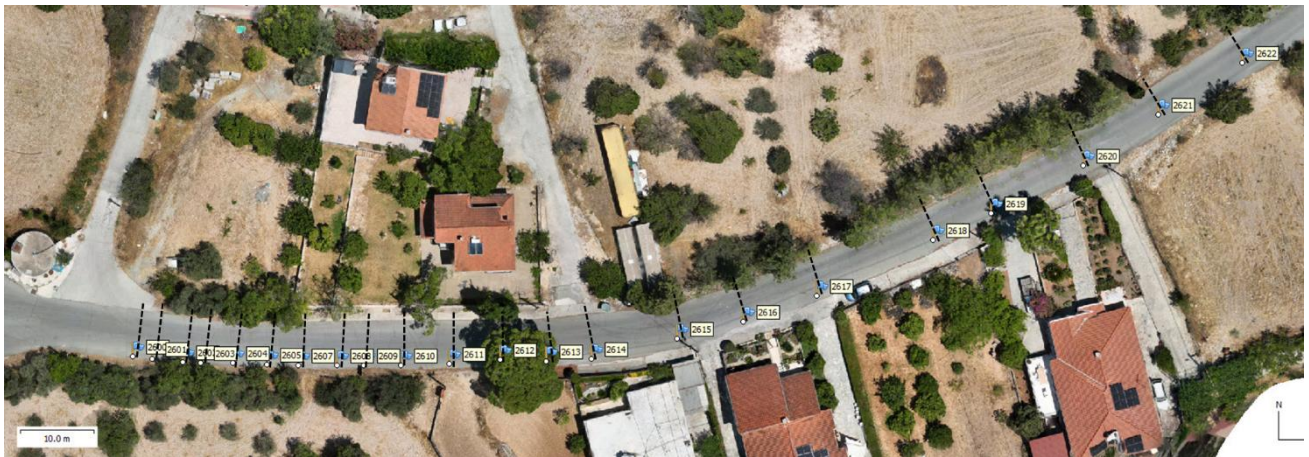
Figure 8. Survey map of GPR measurements in Doros village. Black lines indicate the locations where the GPR profiles were acquired during the field campaign (vertical towards the road) (Drone image captured on 04 July 2025).

A total of 21 perpendicular survey lines were acquired across the study area (Figure 8). These tie-lines were critical in validating the anomalies observed on parallel profiles. They revealed the lateral spread of high-amplitude patches along trench backfill and confirmed hyperbola distortions at specific chainages. Using multiple cross-lines improved confidence in anomaly location and reduced the chance of false positives, which aligns with previous recommendations for utility detection in road corridors. During acquisition, live monitoring of the radargram of the MALA XV monitor allowed immediate inspection of signal quality and detection of any strong reflectors or hyperbolic signatures. The presence of hyperbolas in the radargrams was particularly interesting, as they can indicate buried utilities, junctions, or anomalies related to localised soil disturbance and moisture accumulation near leakage points.

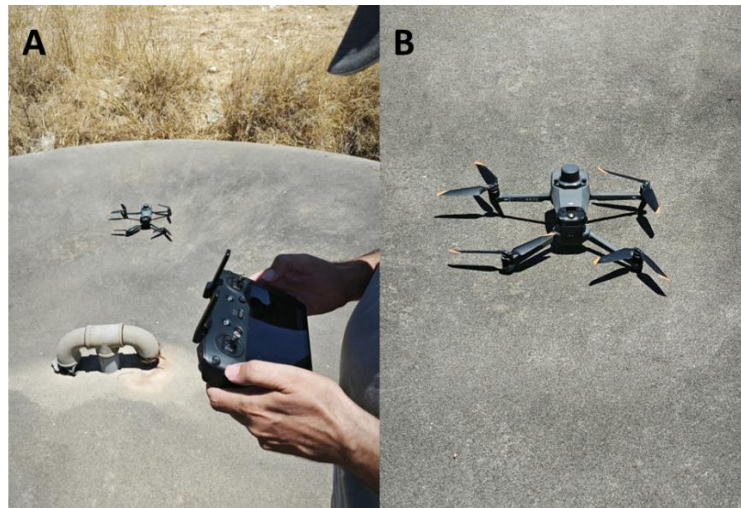
Figure 9. A) Drone pilot operating the UAV during take-off near the survey site; B) Close-up of the DJI Mavic 3 drone on the ground before flight.

To complement the Ground-based geophysical surveys and ensure a precise spatial framework for interpreting GPR measurements, a UAV mapping campaign was carried out using a DJI Mavic 3 drone (Figure 9). The flights were designed to cover both the road segment where the GPR surveys were conducted in Doros and the connecting road leading towards Monagri village (Figure 11A). The UAV survey provided a detailed orthophotomosaic by acquiring very high-resolution imagery with a Ground Sampling Distance (GSD) of 0.1 m. The drone was flown in automated grid missions to ensure systematic coverage and high forward and side overlap, which are essential for robust photogrammetric processing. These images were later processed using structure-from-motion (SfM) photogrammetry, generating a seamless georeferenced orthomosaic. This product was then integrated into a GIS environment to serve as the base map for aligning GPR transects, acoustic sensor locations, and field observations. The advantage of this approach lies in its ability to provide a centimetre-

level visual context of the survey area, capturing both the surface conditions of the road and its surrounding environment. This not only facilitated the precise positioning of geophysical measurements but also ensured reproducibility of the results by documenting the exact layout of the survey area at the time of data collection.

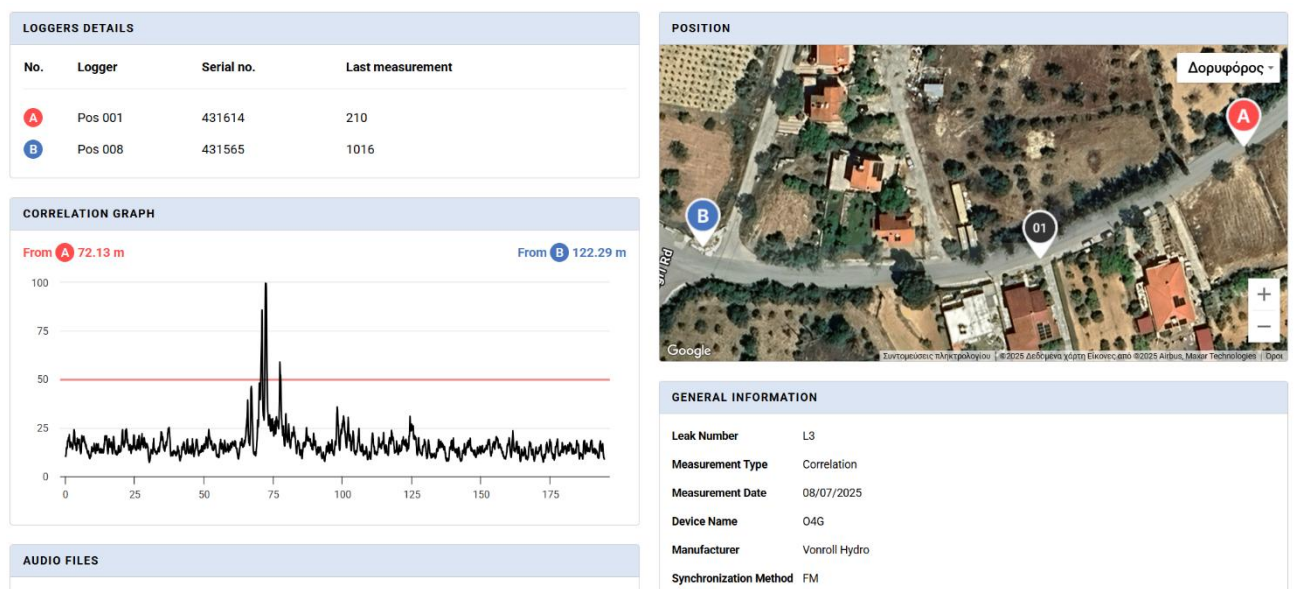
Figure 12. A screenshot from Infraport shows the logger's details, the correlation graph, and the position of the two acoustic sensors with the potential leakage point.
