Seismic Retrofitting of RC Frames with RC Infilling (SERFIN Project)

JRC SCIENTIFIC AND POLICY REPORTS

SERIES Transnational Access report

TA Project Final Report

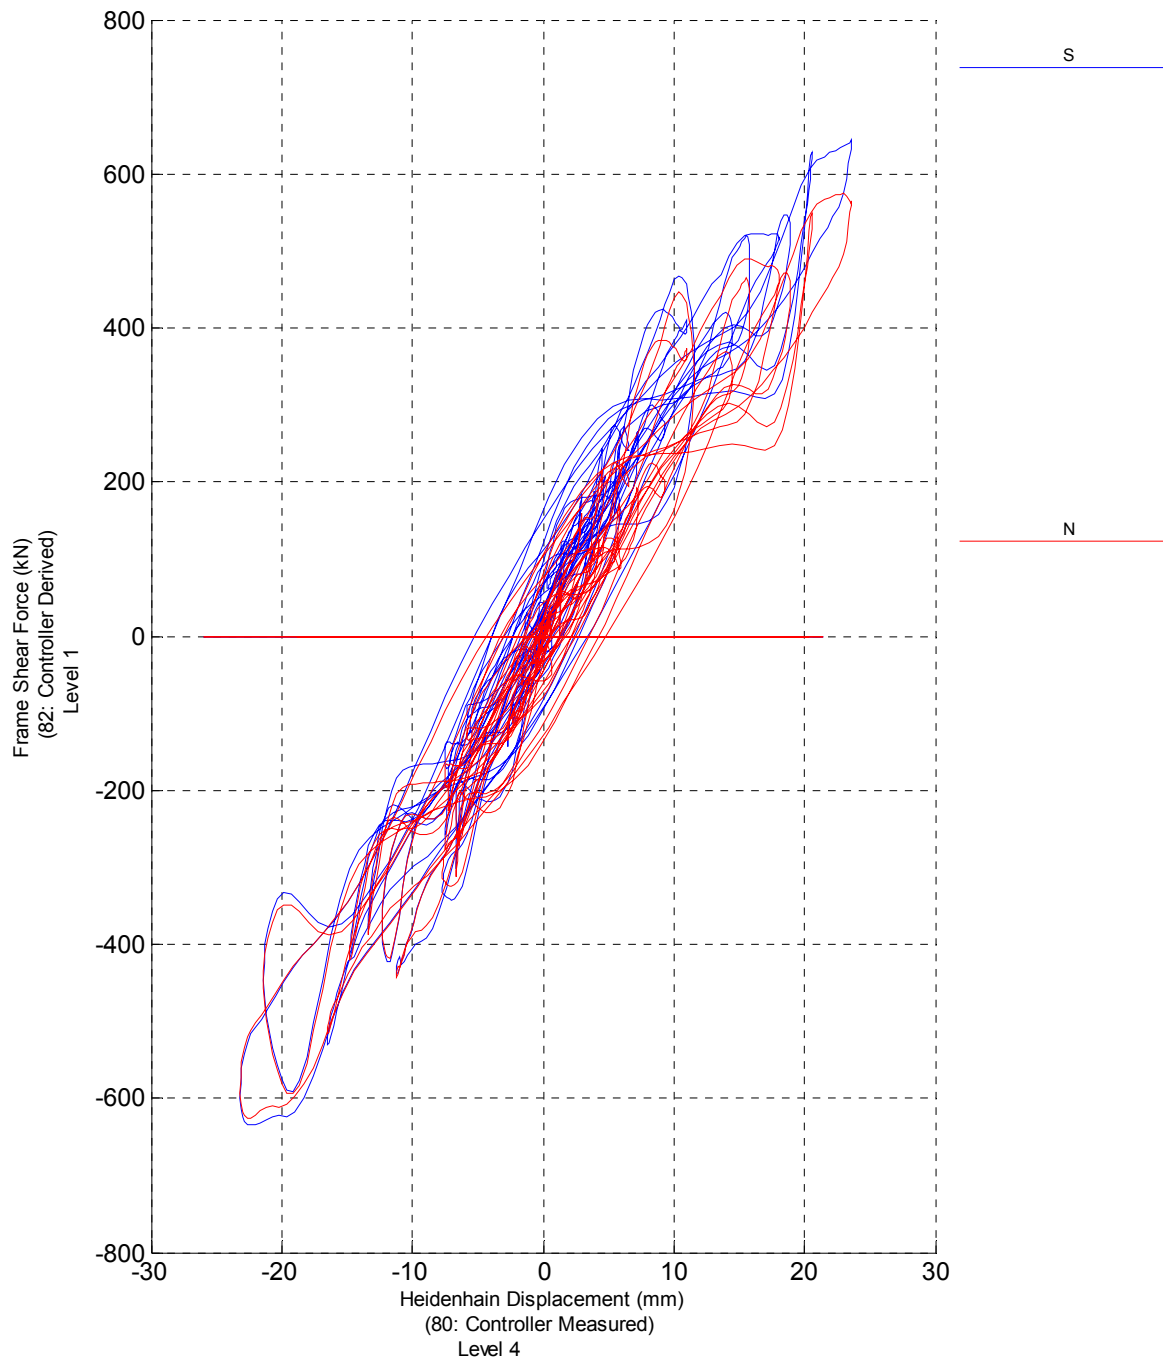
Figure 10.9 0.10g Test - Frame Base Shear/Top Displacement

It should be noted that the variation of the displacements at the first and second stories is shown only up to about 11 seconds, since a problem was encountered with the data acquisition system. The variation of the base shear with the top displacement in each of the frames is shown in Figure 10.9. As it can be observed from the figure, there is very little difference between the two frames. The maximum positive shears were 645kN and 574kN and the maximum negative shears were -634kN and -625kN, for the south and north frames, respectively. Based on the results of the test and the observed damage, it can be considered that both walls reached their cracking moment.

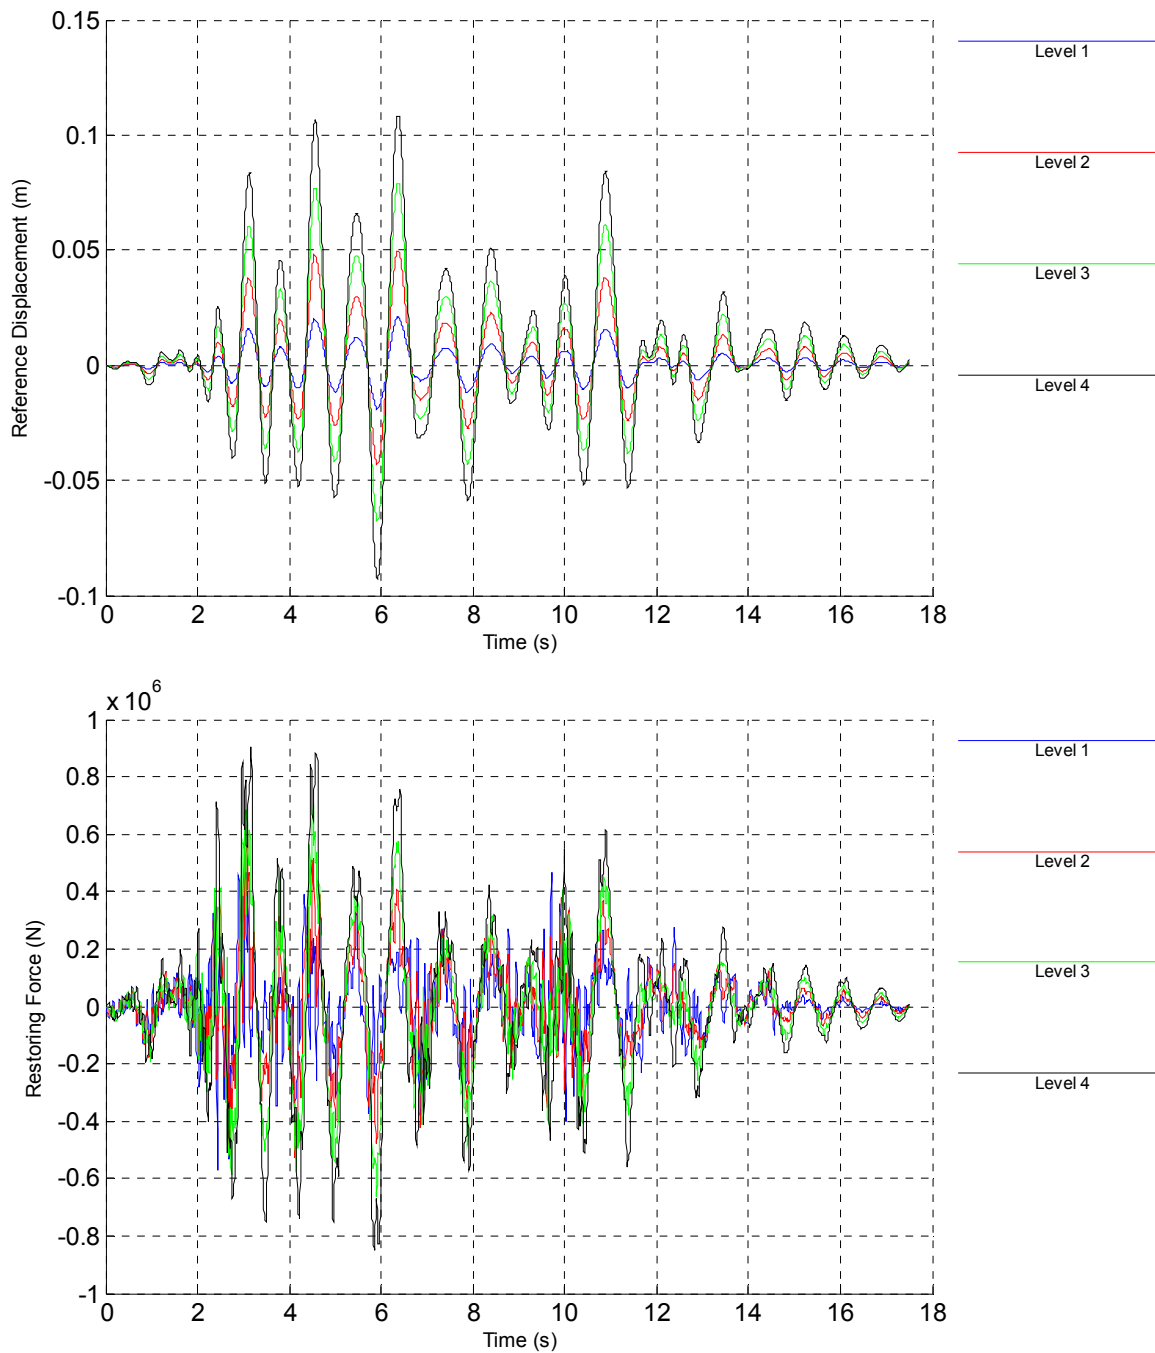
Figure 10.21 0.25g Test - Algorithm Displacement and Force Histories

The 0.25g test was designed to study the performance of the specimen at its ultimate capacity. The maximum top storey displacements were 109 mm and -93 mm (Figure 10.21). Some differences were observed in the base shear between the two frames. As it can be observed in Figure 10.29, the maximum base shear in the positive direction (towards the reaction wall) was 1074kN for the south frame and 1036kN for the north frame, while a larger difference was observed for the negative base shear: -843kN for the south frame and -1011kN for the north frame (at the same displacement time step), providing an indication that the south frame had suffered larger levels of damage than the north frame. This was confirmed by a crack that opened at the ground beam of the foundation at the base of the wall and by a lap-splice failure that appeared in the outer column at the east side of the south frame. CFRP jackets on the bounding columns of the wall prevented a similar failure, thus allowing completion of the experiment.

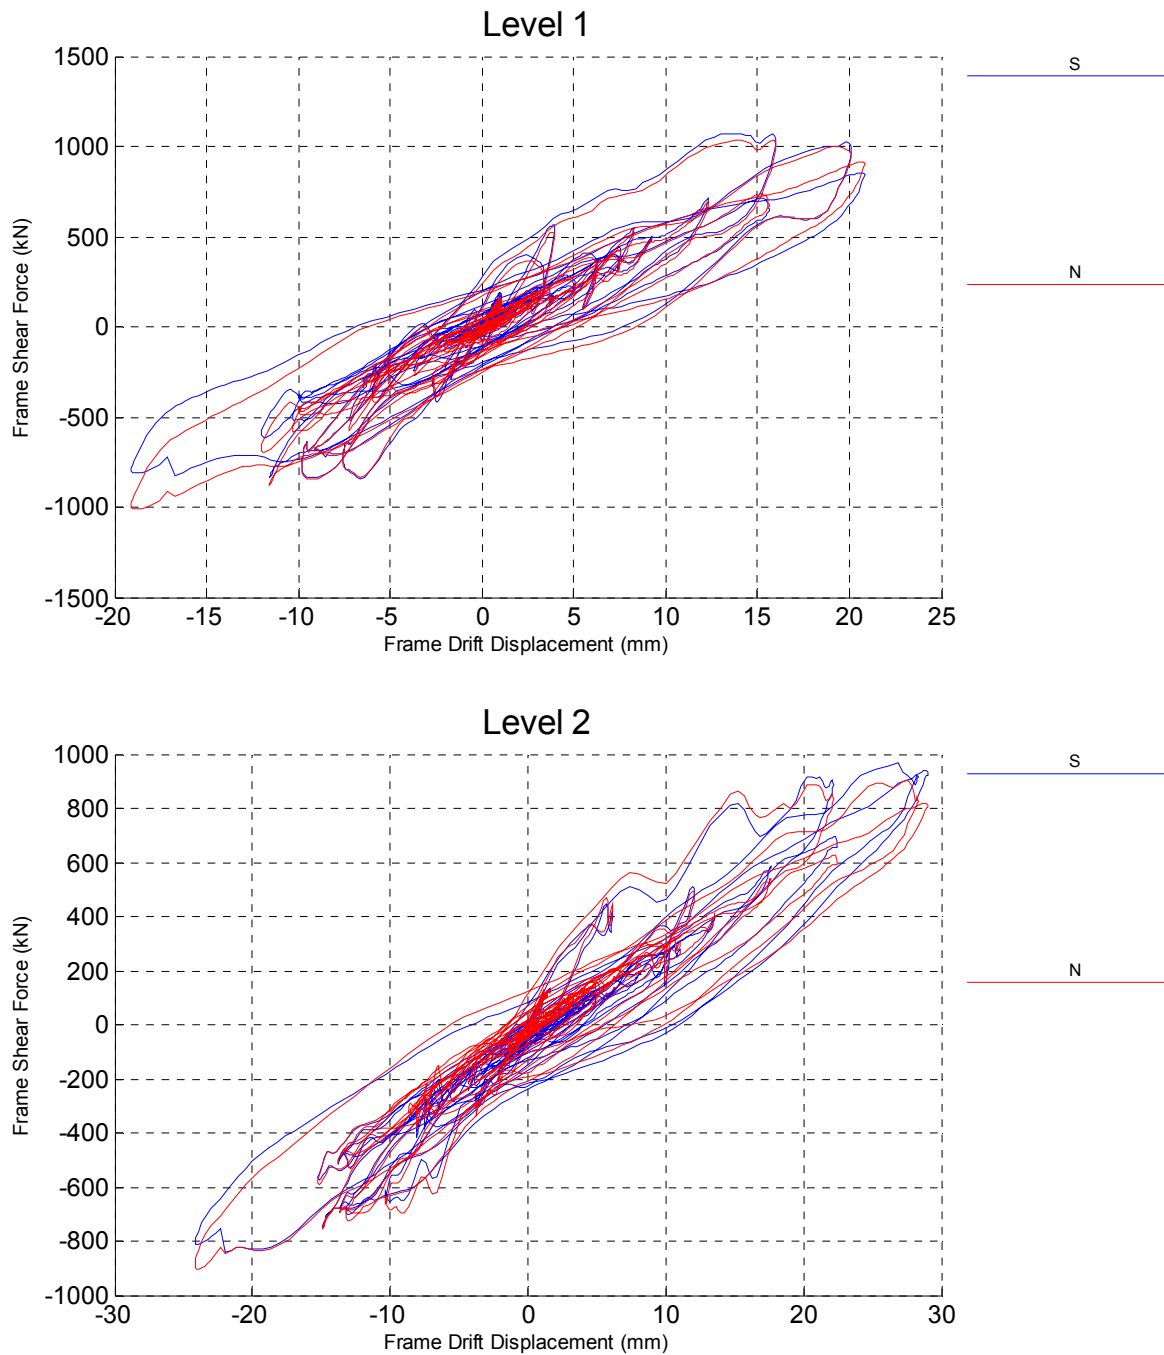
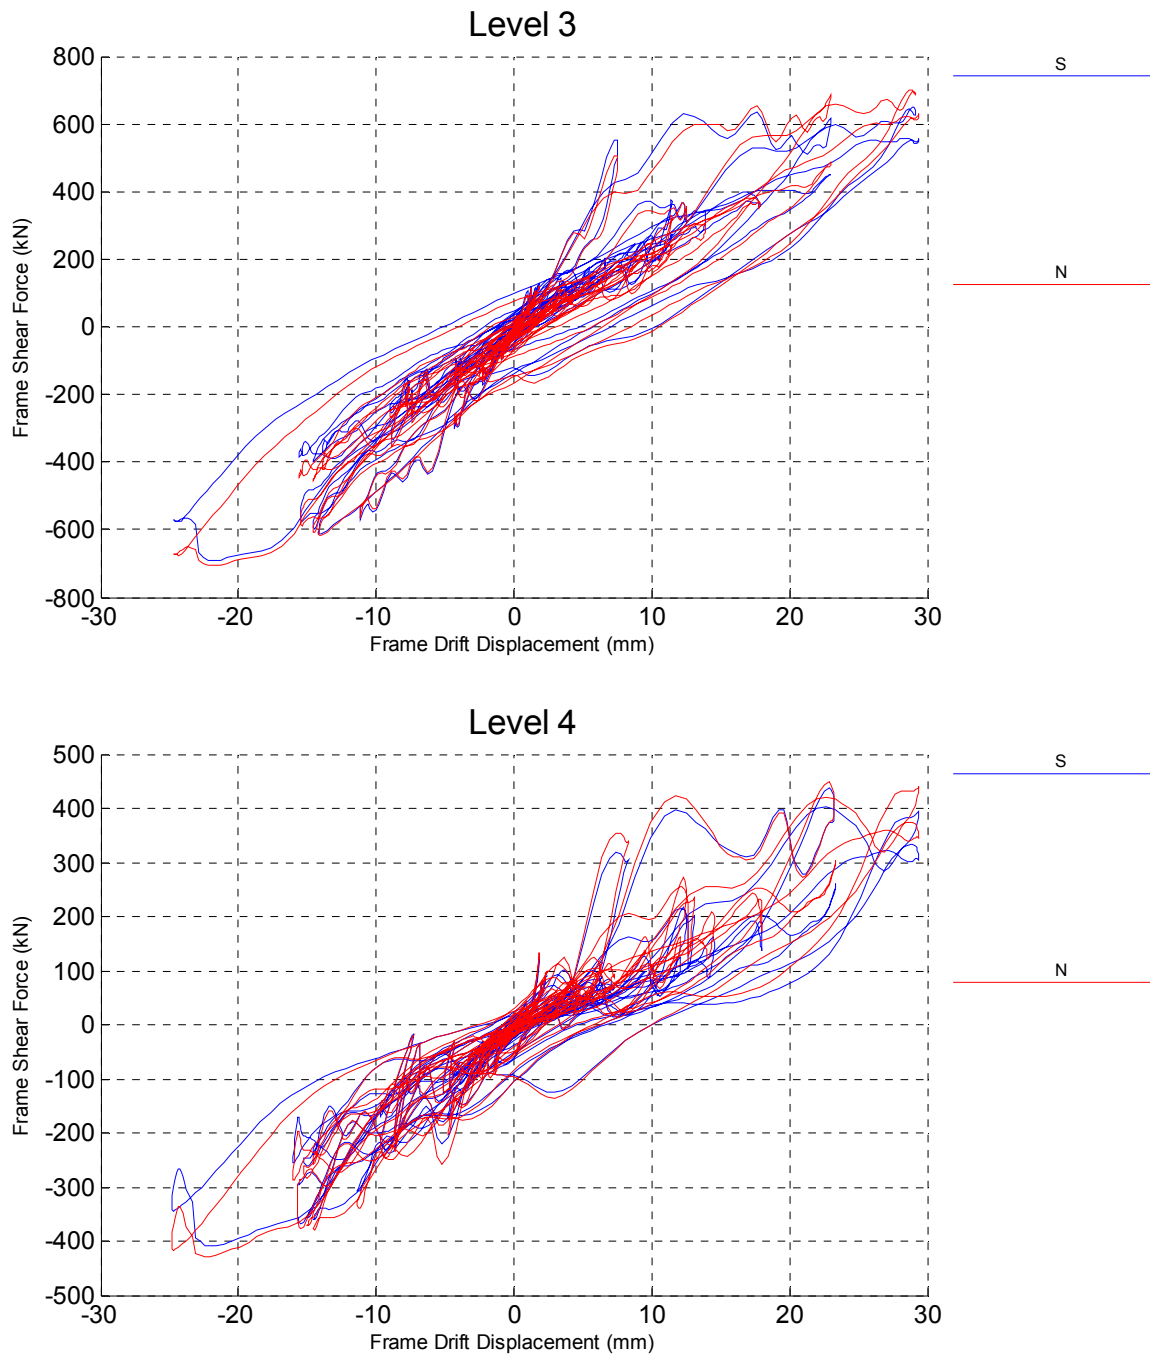
Examining Figure 10.27 and Figure 10.28 it can be observed that there is a steady decrease of the interstorey shear from about 1000kN at the 1st storey to about 400 kN at the top storey. What it can be also seen is that while the interstorey drift at the 1st storey is about 20 mm, the interstorey drift for the upper three floors is on the order of 30 mm, which shows the influence of the larger stiffness of the RC infill wall connection at the base. It can be also observed that the hysteresis loops are stable and provide for some energy dissipation.

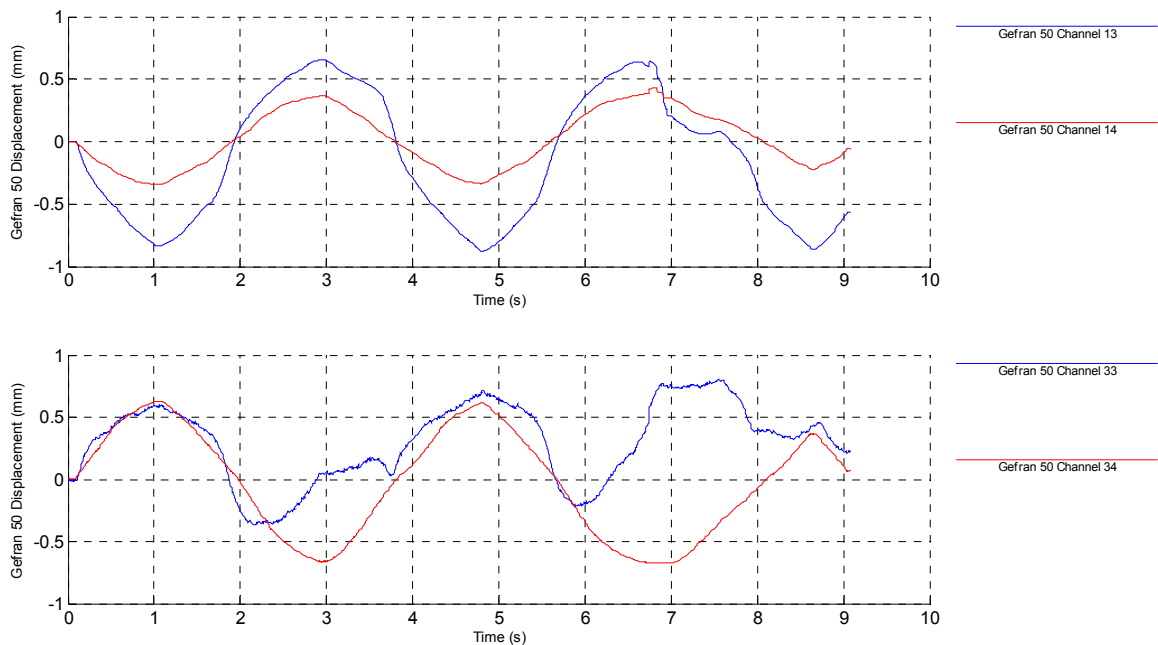
In the ground floor cracks between the infill wall and the surrounding frame were noticed (Figure 8.13), indicating slip between these two elements. However, local measurements show that the horizontal slip (between wall and beam) remained under 0.8mm (Figure 10.56), whereas the vertical slip (between wall and column) remained under 0.4mm (Figure 10.57).

Figure 10.56 Cyclic Test - Local Slip Displacements - Ground Beam

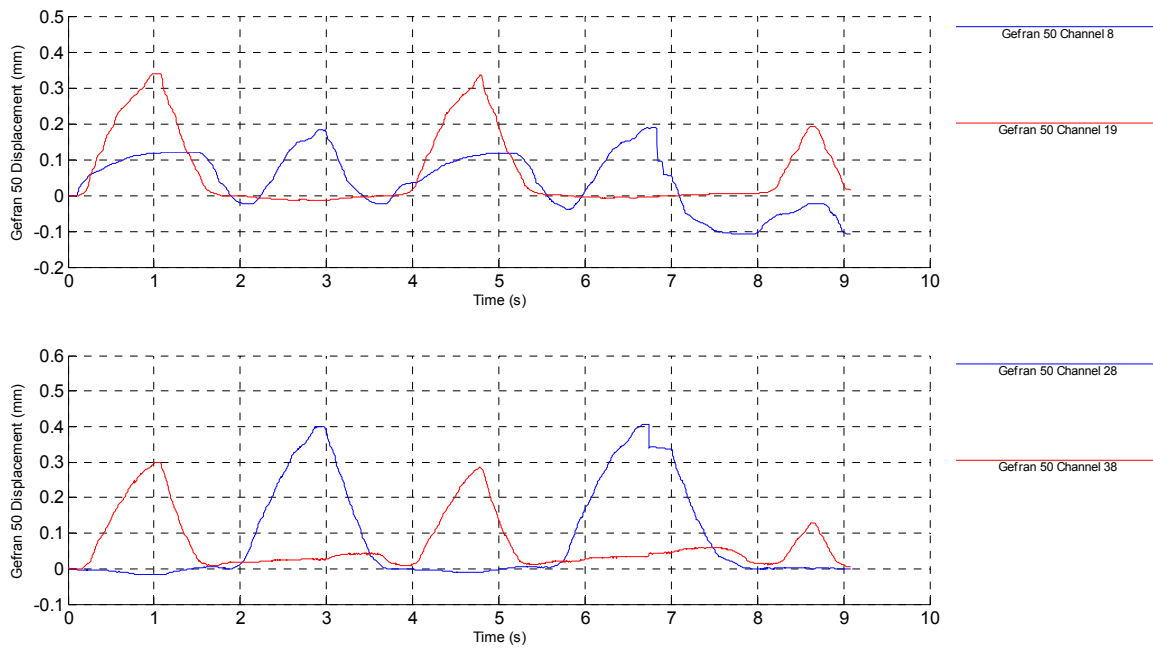
Figure 10.57 Cyclic Test - Local Slip Displacements - Ground Column
